# Access Compliance Report

## Public Rights-of-Way

| Intersection ID: 15293 | Main Street: ARDSLEY_RD | Cross Street: QUEENS_RD | Location: NE |
| ADA ID: 508AB1237295 | Ramp Type: Perp | Initial Pass/Fail: Fail | Overall Compliance: No |

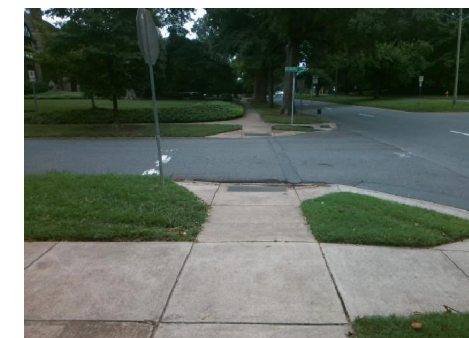
| Severity Score: 13.75 | | | |

**R304.2.2, R304.5.3**

| Compliance | Description | Data | Compliance | Description | Data |
|---|---|---|---|---|---|
| N/A | Ramp Length (in) | 83.0 | No | Ramp Slope (%) | 8.5 |
| Yes | Ramp Width (in) | 61.0 | No | Ramp XSlope (%) | 3.9 |

**Remove & Replace Entire Ramp.**
