Access Compliance Report

Public Rights-of-Way

(Curb Ramps)

Intersection ID: 46810	Main Street: ARBOR_VISTA_DR	Cross Street: CLAUDE_FREEMAN_DR	Location: W
ADA ID: 514A739D10B6	Ramp Type: Combination1	Initial Pass/Fail: Fail	Overall Compliance: No
Severity Score: 26.25			
Codes/Mitigation Info/Possible Solution		Field Measurements/Component Compliance

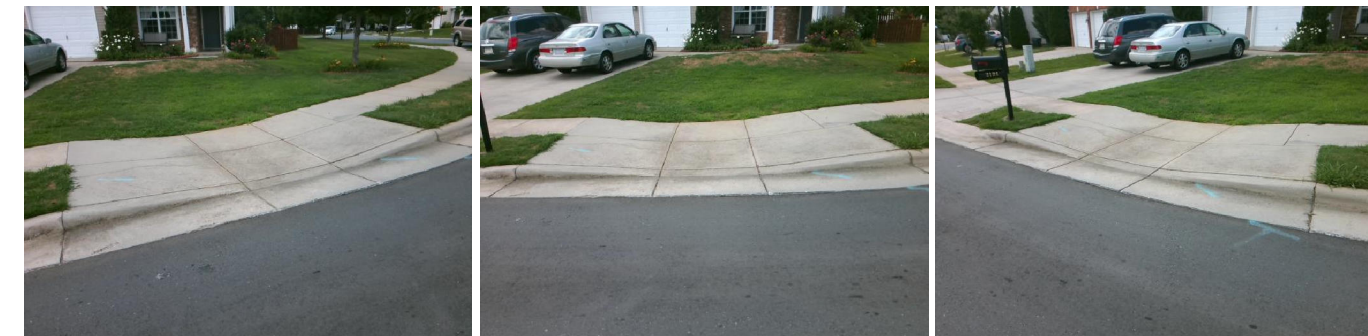
LT RP < 5%

R304.2.2, R304.5.3, R304.3.2

Compliance	Description	Data	Compliance	Description	Data
N/A	Ramp Length LT (in)	68.0	N/A	Ramp Length RT (in)	65.0
Yes	Ramp Width LT (in)	48.0	Yes	Ramp Width RT (in)	48.0
Yes	Ramp Slope LT (%)	4.5	No	Ramp Slope RT (%)	11.8
Yes	Ramp XSlope LT (%)	1.2	No	Ramp XSlope RT (%)	2.1
N/A	Ramp Length (in)	47.0	No	Ramp Slope (%)	15.2
Yes	Ramp Width (in)	48.0	No	Ramp XSlope (%)	2.3
N/A	Flare Type LT	N/A	N/A	Flare Type RT	N/A
N/A	Flare Slope LT (%)	N/A	N/A	Flare Slope RT (%)	N/A
N/A	Flare Traversable LT?	N/A	N/A	Flare Traversable RT?	N/A
N/A	Landing Length (in)	N/A	N/A	DWS Provided?	N/A
N/A	Landing Width (in)	N/A	N/A	DWS Contrast?	N/A
N/A	Landing Slope (%)	N/A	N/A	DWS Length (in)	N/A
N/A	Landing X Slope (%)	N/A	N/A	DWS Full Width?	N/A
N/A	Landing Curb? (Y/N)	N/A	N/A	DWS Offset (in)	N/A
N/A	Shared Landing?	N/A			
N/A	Gutter Ponding?	N/A	N/A	Gutter Slope (%)	N/A
N/A	Gutter Lip Ht (in)	N/A	N/A	Gutter X Slope (%)	N/A
N/A	Painted X Walk1?	No	N/A	Painted X Walk2?	N/A

Remove & Replace Entire Ramp.
