Access Compliance Report

Public Rights-of-Way

(Curb Ramps)

Intersection ID: N/A		Main Street: SHASTA_LN		Cross Street: SUNBURY_LN		Location: S			
ADA ID: 515E12DCD396		Ramp Type: Directional1		Initial Pass/Fail: Fail		Overall Compliance: No		Severity Score: 1.25	
Codes/Mitigation Info/Possible Solution				Field Measurements/Component Compliance					
<div>

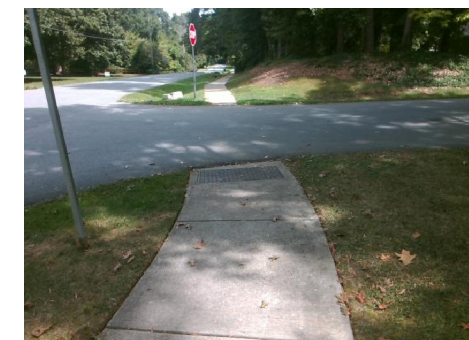
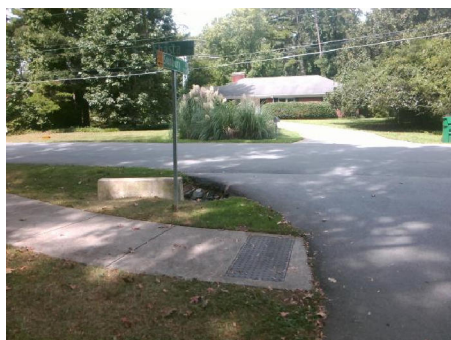
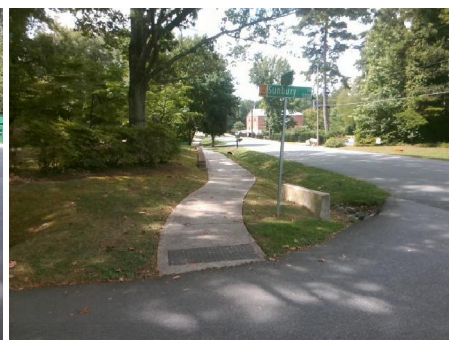
</div> <div>Possible Solutions:</div> <div>Remove & Replace Entire Ramp.</div> <div>Surveyor Notes:</div> <div>N/A</div> <div>PROW/ADA:</div> <div>R304.5.3</div> <div>Street 1 Name</div> <div>SUNBURY LN</div> <div>Stop Condition-Street 1</div> <div>StopSign</div> <div>Street 2 Name</div> <div>N/A</div> <div>Stop Condition-Street 2</div> <div>N/A</div> <div>Total Cost:</div> <div>\$</div> <div>1600.00</div>				Compliance	Description	Data	Compliance	Description	Data
				N/A	Ramp Length (in)	74.0	N/A	Grade Break?	N/A
				Yes	Ramp Width (in)	60.0	N/A	Grade Break Slope (%)	0.0
				Yes	Ramp Slope (%)	1.8	N/A	Grade Break XSlope (%)	0.0

No	Ramp XSlope (%)	2.9			
				N/A	Flare Type LT	N/A	N/A	Flare Type RT	N/A
				N/A	Flare Slope LT (%)	N/A	N/A	Flare Slope RT (%)	0.0
				N/A	Flare Traversable LT?	N/A	N/A	Flare Traversable RT?	N/A
				N/A	Landing Length (in)	0.0	N/A	DWS Provided?	N/A
				N/A	Landing Width (in)	0.0	N/A	DWS Contrast?	N/A
				N/A	Landing Slope (%)	0.0	N/A	DWS Length (in)	N/A
				N/A	Landing X Slope (%)	0.0	N/A	DWS Full Width?	N/A
				N/A	Landing Curb? (Y/N)	N/A	N/A	DWS Offset LT (in)	N/A
				N/A	Shared Landing?	N/A	N/A	DWS Offset RT (in)	N/A
				N/A	Gutter Ponding?	0.0	N/A	Gutter Slope (%)	N/A
				N/A	Gutter Lip Ht (in)	0.0	N/A	Gutter X Slope (%)	N/A
				N/A	Painted X Walk1?	No		Road Slope (%)	4.2
					X Walk 1 Direction	To NE		Road X Slope (%)	2.1
					X Walk 1 Width (in)	N/A		Clear Space?	N/A
					X Walk 1 Slope (%)	4.2	N/A	Clear Space to XWalk (in)	N/A
					X Walk 1 X Slope (%)	2.1	N/A	Storm Grate/Utility Hazard?	N/A
				N/A	Ramp inside XWalk1?	N/A		Storm Grate/Utility Type

N/A	Any Obstructions?	N/A			N/A
					Obstruction Type		Yes	Surface Condition? (G/P)	Good
							N/A	Curb Slope (%)	3.1
