# Access Compliance Report

## Public Rights-of-Way

### (Curb Ramps)

Intersection ID: 16207	Main Street: MONROE_RD	Cross Street: COMMODORE_ST	Location: SW
ADA ID: 51F20A6C0A47	Ramp Type: Combination1Diag	Initial Pass/Fail: Fail	Overall Compliance: No
		Severity Score: 0

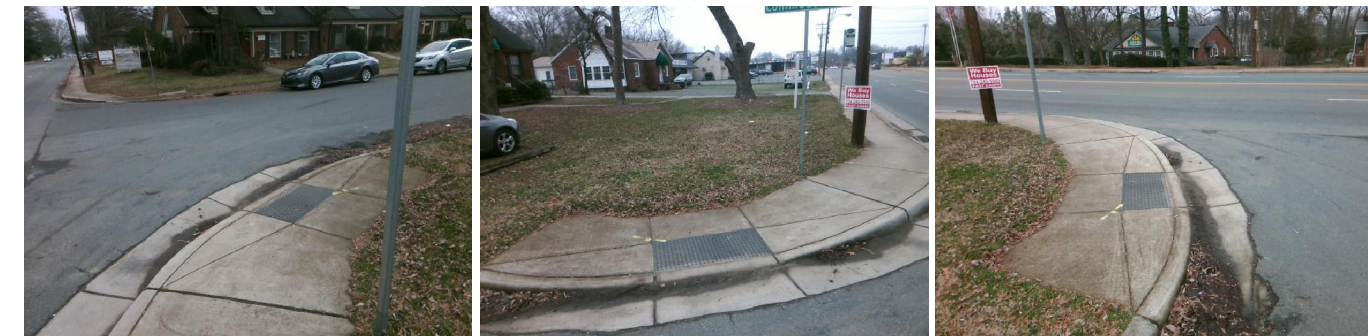
**Not Found, R304.5.1, R304.3.2**

Compliance	Description	Data	Compliance	Description	Data
N/A	Ramp Length LT (in)	51.0	N/A	Ramp Length RT (in)	53.0
No	Ramp Width LT (in)	36.0	No	Ramp Width RT (in)	36.0
Yes	Ramp Slope LT (%)	7.8	No	Ramp Slope RT (%)	10.2
Yes	Ramp XSlope LT (%)	1.1	Yes	Ramp XSlope RT (%)	0.9
N/A	Ramp Length (in)	25.0	Yes	Ramp Slope (%)	6.3
Yes	Ramp Width (in)	48.0	Yes	Ramp XSlope (%)	1.0
N/A	Flare Type LT	N/A	N/A	Flare Type RT	N/A
N/A	Flare Slope LT (%)	N/A	N/A	Flare Slope RT (%)	N/A
N/A	Flare Traversable LT?	N/A	N/A	Flare Traversable RT?	N/A
N/A	Landing Length (in)	N/A	N/A	DWS Provided?	N/A
N/A	Landing Width (in)	N/A	N/A	DWS Contrast?	N/A
N/A	Landing Slope (%)	N/A	N/A	DWS Length (in)	N/A
N/A	Landing X Slope (%)	N/A	N/A	DWS Full Width?	N/A
N/A	Landing Curb? (Y/N)	N/A	N/A	DWS Offset (in)	N/A
N/A	Shared Landing?	N/A			
N/A	Gutter Ponding?	N/A	N/A	Gutter Slope (%)	N/A
N/A	Gutter Lip Ht (in)	N/A	N/A	Gutter X Slope (%)	N/A
N/A	Painted X Walk1?	No	N/A	Painted X Walk2?	No

X Walk 1 Direction	To SE		X Walk 2 Direction	To NE
	X Walk 1 Width (in)	N/A		X Walk 2 Width (in)	N/A
	X Walk 1 Slope (%)	0.1		X Walk 2 Slope (%)	0.5
	X Walk 1 X Slope (%)	0.2		X Walk 2 X Slope (%)	2.6
N/A	Ramp inside XWalk1?	N/A	N/A	Ramp inside XWalk2?	N/A
	Road Slope (%)	1.1		Clear Space?	N/A
	Road X Slope (%)	0.4	N/A	Clear Space to XWalk (in)	N/A
			N/A	Any Obstruction?	N/A
				Obstruction Type	N/A
			N/A	Storm Grate/Utility Hazard?	N/A
				Storm Grate/Utility Type	N/A
					N/A
Yes	Surface Condition? (G/P)	Good			
	Curb Slope (%)	8.4

**Remove & Replace Curb Ramp With Two New Directional Ramps or Equivalent.**
