| Intersection ID: 28287 | Main Street: BRANDON_BROOK_DR | Cross Street: OLD_ARDREY_KELL_RD | Location: | SE |
| ADA ID: 525A61025305 | Ramp Type: Perp | Initial Pass/Fail: Fail | Overall Compliance: No | Severity Score: 37.5 |

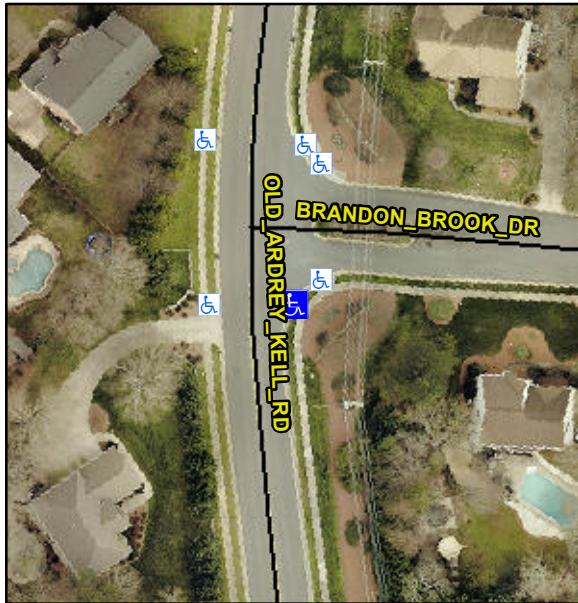
Not Found, R304.2.2, R304.5.3

| Possible Solutions: | | | Compliance | Description | Data | Compliance | Description | Data |
|--|--|--|---|---|---|---|---|---|
| Remove & Replace Entire Ramp. | | | N/A | Ramp Length (in) | 94.0 | No | Ramp Slope (%) | 9.1 |
| | | | Yes | Ramp Width (in) | 48.0 | No | Ramp XSlope (%) | 8.8 |

Remove & Replace Entire Ramp.
