Access Compliance Report

Public Rights-of-Way

(Curb Ramps)

Intersection ID: 17819	Main Street: LYTTLETON_DR	Cross Street: N_SHARON_AMITY_RD	Location: SW
ADA ID: 536D9C25B8BA	Ramp Type: ParaDiag	Initial Pass/Fail: Fail	Overall Compliance: No
			Severity Score: 13.75

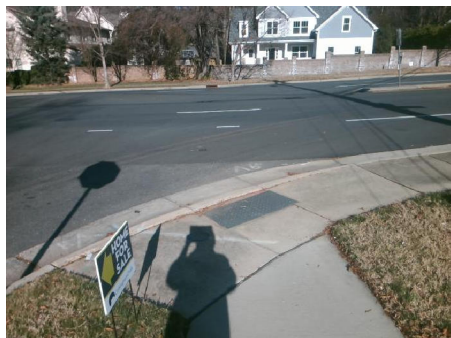
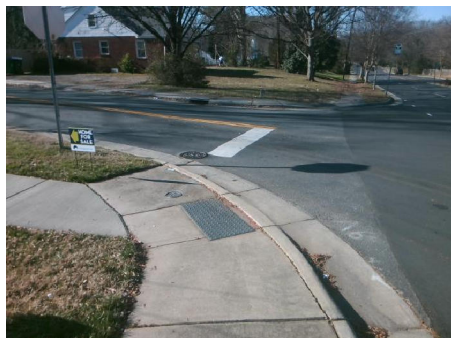
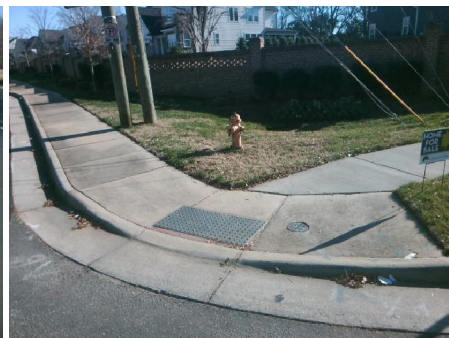
Surveyor Notes: CURB LIP 1.0			N/A	Shared Landing?	N/A				
PROW/ADA: R304.3.2, R304.5.3			N/A	Gutter Ponding?	N/A	N/A	Gutter Slope (%)	N/A	
			N/A	Gutter Lip Ht (in)	N/A	N/A	Gutter X Slope (%)	N/A	
			N/A	Painted X Walk1?	No	N/A	Painted X Walk2?	No	
				X Walk 1 Direction	To NE		X Walk 2 Direction	To NW	
			N/A	X Walk 1 Width (in)	N/A	N/A	X Walk 2 Width (in)	N/A	
				X Walk 1 Slope (%)	2.8		X Walk 2 Slope (%)	0.1	
				X Walk 1 X Slope (%)	1.5		X Walk 2 X Slope (%)	0.0	
			N/A	Ramp inside XWalk1?	N/A	N/A	Ramp inside XWalk2?	N/A	
				Road Slope (%)	0.3	N/A	Clear Space?	N/A	
				Road X Slope (%)	0.2	N/A	Clear Space to XWalk (in)	N/A	
			N/A	Any Obstructions?	N/A	N/A	Storm Grate/Utility Hazard?	N/A	
				Obstruction Type			Storm Grate/Utility Type		
Total Cost:			\$	3200.00	N/A			N/A	
						Yes	Surface Condition? (G/P)	Good	
						N/A	Curb Slope (%)	5.9

<div>Street 1 Name<div>N SHARON AMITY RD</div></div> <div>Stop Condition-Street 1<div>None</div></div> <div>Street 2 Name<div>LYTTLETON DR</div></div> <div>Stop Condition-Street 2<div>StopSign</div></div>	Possible Solutions: Remove & Replace Curb Ramp With Two New Directional Ramps or Equivalent.			Compliance	Description	Data	Compliance	Description	Data
				N/A	Ramp Length LT (in)	54.0	N/A	Ramp Length RT (in)	52.0
				Yes	Ramp Width LT (in)	60.0	Yes	Ramp Width RT (in)	60.5
				No	Ramp Slope LT (%)	11.5	Yes	Ramp Slope RT (%)	7.6
				No	Ramp XSlope LT (%)	3.0	No	Ramp XSlope RT (%)	2.1
				N/A	Landing Length (in)	N/A	N/A	DWS Provided?	N/A
				N/A	Landing Width (in)	N/A	N/A	DWS Contrast?	N/A
				N/A	Landing Slope (%)	N/A	N/A	DWS Length (in)	N/A
				N/A	Landing X Slope (%)	N/A	N/A	DWS Full Width?	N/A
				N/A	Landing Curb? (Y/N)	N/A	N/A	DWS Offset (in)	N/A
