Access Compliance Report

Public Rights-of-Way

(Curb Ramps)

Intersection ID: 53270	Main Street: MONROE_RD	Cross Street: MERIDIAN_CENTER_DR	Location: N
ADA ID: 53BCD5EFABE9	Ramp Type: Directional1	Initial Pass/Fail: Fail	Overall Compliance: No
Codes/Mitigation Info/Possible Solution		Field Measurements/Component Compliance	
Severity Score: 13.75

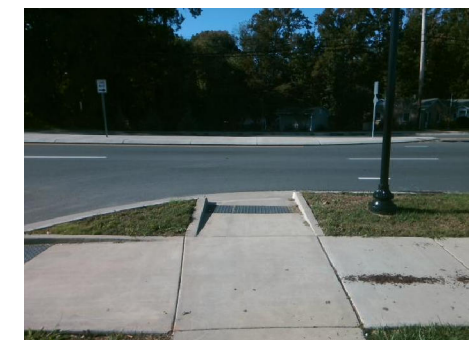
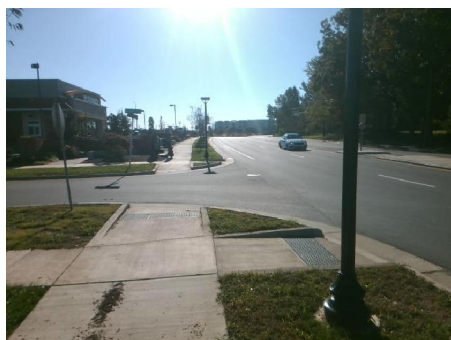
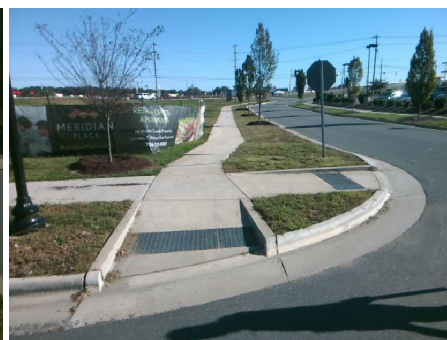
R304.2.2, R304.5.3

Compliance	Description	Data	Compliance	Description	Data
N/A	Ramp Length (in)	77.0	N/A	Grade Break?	N/A
Yes	Ramp Width (in)	67.0	N/A	Grade Break Slope (%)	0.0
No	Ramp Slope (%)	10.1	N/A	Grade Break XSlope (%)	0.0
No	Ramp XSlope (%)	3.4			
N/A	Flare Type LT	N/A	N/A	Flare Type RT	N/A
N/A	Flare Slope LT (%)	N/A	N/A	Flare Slope RT (%)	0.0
N/A	Flare Traversable LT?	N/A	N/A	Flare Traversable RT?	N/A
N/A	Landing Length (in)	0.0	N/A	DWS Provided?	N/A
N/A	Landing Width (in)	0.0	N/A	DWS Contrast?	N/A
N/A	Landing Slope (%)	0.0	N/A	DWS Length (in)	N/A
N/A	Landing X Slope (%)	0.0	N/A	DWS Full Width?	N/A
N/A	Landing Curb? (Y/N)	N/A	N/A	DWS Offset LT (in)	N/A
N/A	Shared Landing?	N/A	N/A	DWS Offset RT (in)	N/A
N/A	Gutter Ponding?	0.0	N/A	Gutter Slope (%)	N/A
N/A	Gutter Lip Ht (in)	0.0	N/A	Gutter X Slope (%)	N/A
N/A	Painted X Walk1?	No		Road Slope (%)	0.7
	X Walk 1 Direction	To SW		Road X Slope (%)	1.0
	X Walk 1 Width (in)	N/A		Clear Space?	N/A

X Walk 1 Slope (%)	0.7	N/A	Clear Space to XWalk (in)	N/A
	X Walk 1 X Slope (%)	1.0	N/A	Storm Grate/Utility Hazard?	N/A
N/A	Ramp inside XWalk1?	N/A		Storm Grate/Utility Type	
N/A	Any Obstructions?	N/A			N/A
	Obstruction Type		Yes	Surface Condition? (G/P)	Good
			N/A	Curb Slope (%)	7.7

Remove & Replace Entire Ramp.
