Intersection ID: 53743	Main Street: SMITH_RD	Cross Street: CANTERBURY_CASTLE_DR	Location:	SE
ADA ID: 55F20481F6A3	Ramp Type: Perp	Initial Pass/Fail: Fail	Overall Compliance: No	Severity Score: 21.25

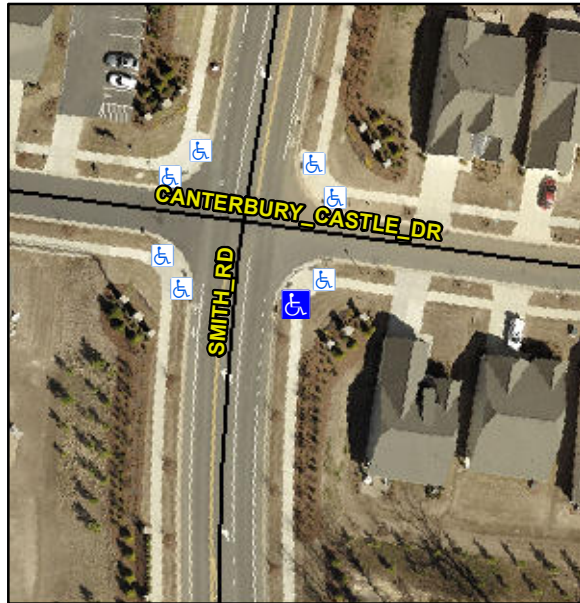
R304.5.1, R304.5.3

Possible Solutions:			Compliance	Description	Data	Compliance	Description	Data
Remove & Replace Entire Ramp.	N/A	Ramp Length (in)	94.0	Yes	Ramp Slope (%)	5.7		
	No	Ramp Width (in)	44.0	No	Ramp XSlope (%)	5.3		
	N/A	Flare Type LT	N/A	N/A	Flare Type RT	N/A		
	N/A	Flare Slope LT (%)	N/A	N/A	Flare Slope RT (%)	N/A		
	N/A	Flare Traversable LT?	N/A	N/A	Flare Traversable RT?	N/A		
	N/A	Landing Length (in)	N/A	N/A	DWS Provided?	N/A		
	N/A	Landing Width (in)	N/A	N/A	DWS Contrast?	N/A		
	N/A	Landing Slope (%)	N/A	N/A	DWS Length (in)	N/A		
	N/A	Landing X Slope (%)	N/A	N/A	DWS Full Width?	N/A		
	N/A	Landing Curb? (Y/N)	N/A	N/A	DWS Offset (in)	N/A		
	N/A	Shared Landing?	N/A					
	N/A	Gutter Ponding?	N/A	N/A	Gutter Slope (%)	N/A		
Surveyor Notes: N/A	N/A	Gutter Lip Ht (in)	1.0	N/A	Gutter X Slope (%)	N/A		
	N/A	Painted X Walk1?	No	N/A	Painted X Walk2?	N/A		
		X Walk 1 Direction	To NW		X Walk 2 Direction	N/A		
	N/A	X Walk 1 Width (in)	N/A	N/A	X Walk 2 Width (in)	N/A

X Walk 1 Slope (%)	6.0		X Walk 2 Slope (%)	N/A		
		X Walk 1 X Slope (%)	2.5		X Walk 2 X Slope (%)	N/A		
	N/A	Ramp inside XWalk1?	N/A	N/A	Ramp inside XWalk2?	N/A		
		Road Slope (%)	N/A	N/A	Clear Space?	N/A		
		Road X Slope (%)	N/A	N/A	Clear Space to XWalk (in)	N/A		
	N/A	Any Obstructions?	N/A	N/A	Storm Grate/Utility Hazard?	N/A		
		Obstruction Type			Storm Grate/Utility Type			
			N/A			N/A		
			Yes	Surface Condition? (G/P)	Good			
Total Cost:	\$	1850.00

Remove & Replace Entire Ramp.
