# Access Compliance Report

## Public Rights-of-Way

### (Curb Ramps)

Intersection ID: 26242	Main Street: BAYBROOK_LN	Cross Street: BEVINGTON_PL	Location: NW
ADA ID: 56240164DA04	Ramp Type: PerpDiag	Initial Pass/Fail: Fail	Overall Compliance: No
		Severity Score: 22.5

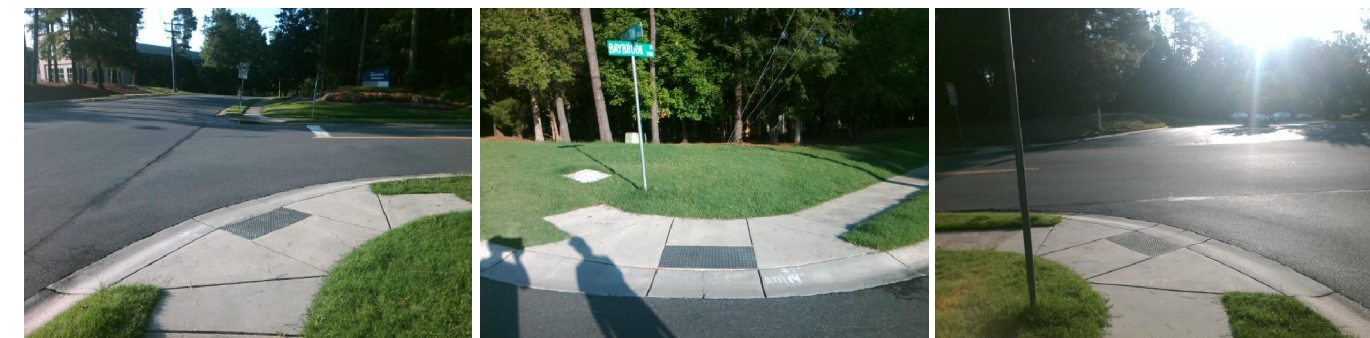
Compliance	Description	Data	Compliance	Description	Data
N/A	Ramp Length (in)	68.0	No	Ramp Slope (%)	8.6
No	Ramp Width (in)	47.5	No	Ramp XSlope (%)	4.5
N/A	Flare Type LT	N/A	N/A	Flare Type RT	N/A
N/A	Flare Slope LT (%)	N/A	N/A	Flare Slope RT (%)	N/A
N/A	Flare Traversable LT?	N/A	N/A	Flare Traversable RT?	N/A
N/A	Landing Length (in)	N/A	N/A	DWS Provided?	N/A
N/A	Landing Width (in)	N/A	N/A	DWS Contrast?	N/A
N/A	Landing Slope (%)	N/A	N/A	DWS Length (in)	N/A
N/A	Landing X Slope (%)	N/A	N/A	DWS Full Width?	N/A
N/A	Landing Curb? (Y/N)	N/A	N/A	DWS Offset (in)	N/A
N/A	Shared Landing?	N/A			
N/A	Gutter Ponding?	N/A	N/A	Gutter Slope (%)	N/A
N/A	Gutter Lip Ht (in)	N/A	N/A	Gutter X Slope (%)	N/A
N/A	Painted X Walk1?	No	N/A	Painted X Walk2?	No
	X Walk 1 Direction	To SE		X Walk 2 Direction	To NE
N/A	X Walk 1 Width (in)	N/A	N/A	X Walk 2 Width (in)	N/A
	X Walk 1 Slope (%)	3.4		X Walk 2 Slope (%)	0.3
	X Walk 1 X Slope (%)	0.5		X Walk 2 X Slope (%)	6.0

N/A	Ramp inside XWalk1?	N/A	N/A	Ramp inside XWalk2?	N/A
	Road Slope (%)	2.3	N/A	Clear Space?	N/A
	Road X Slope (%)	2.3	N/A	Clear Space to XWalk (in)	N/A
N/A	Any Obstructions?	N/A	N/A	Storm Grate/Utility Hazard?	N/A
	Obstruction Type			Storm Grate/Utility Type	
		N/A			N/A
			Yes	Surface Condition? (G/P)	Good

**Remove & Replace Curb Ramp With Two New Directional Ramps or Equivalent.**
