Access Compliance Report

Public Rights-of-Way

| Intersection ID: 11008 | Main Street: SHAMROCK_DR | Cross Street: THE_PLAZA | Location: SE |
| ADA ID: 56AF479381D0 | Ramp Type: Para | Initial Pass/Fail: Fail | Overall Compliance: No |

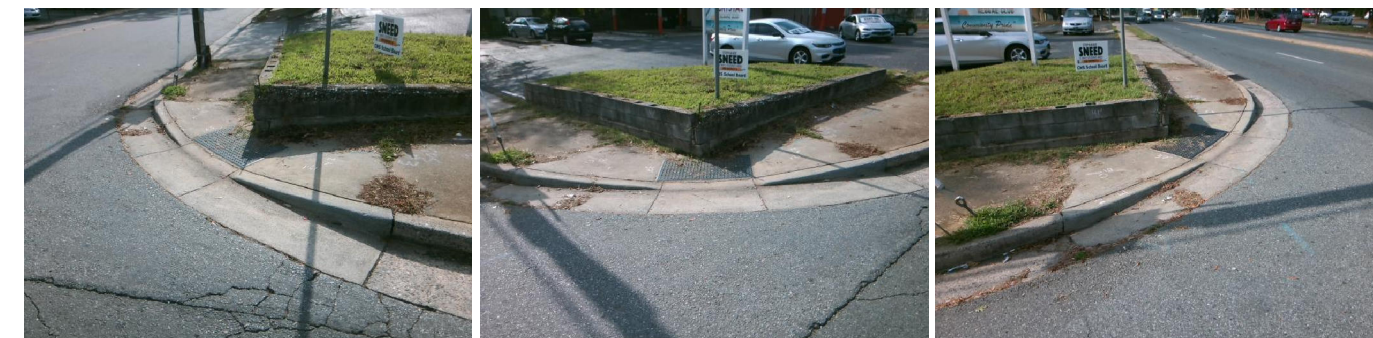
LT RP < 5%

| Compliance | Description | Data | Compliance | Description | Data |
|---|---|---|---|---|---|
| No | Ramp Width LT (in) | 37.0 | No | Ramp Width RT (in) | 44.0 |
| Yes | Ramp Slope LT (%) | 1.9 | No | Ramp Slope RT (%) | 14.1 |
| Yes | Ramp XSlope LT (%) | 1.5 | No | Ramp XSlope RT (%) | 2.6 |

Remove & Replace Entire Ramp.
