Access Compliance Report

Public Rights-of-Way

(Curb Ramps)

Intersection ID: 45829	Main Street: PATRICIA_ANN_LN	Cross Street: CHRISTENBURY_HILLS_LN	Location: SW
ADA ID: 56F089DB6458	Ramp Type: PerpDiag	Initial Pass/Fail: Fail	Overall Compliance: No
		Severity Score: 30

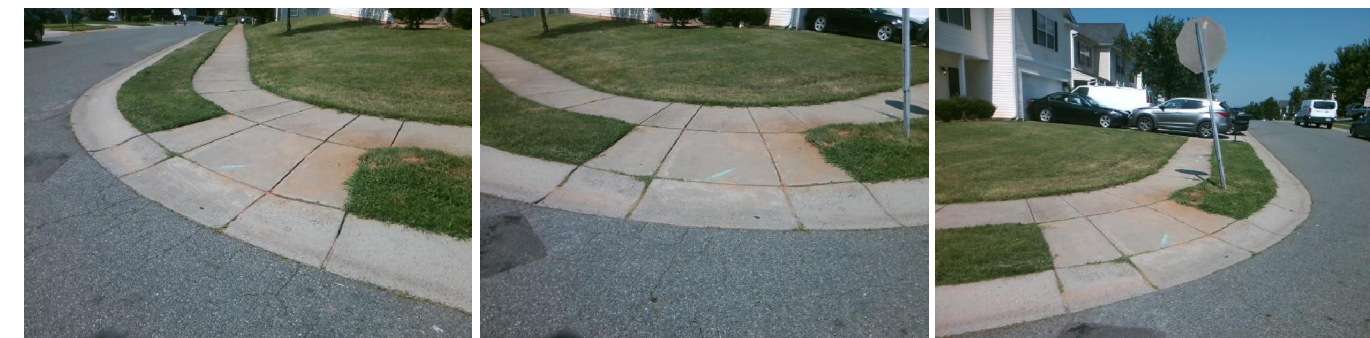
Not Found, R304.5.1, R304.2.2

Compliance	Description	Data	Compliance	Description	Data
N/A	Ramp Length (in)	47.5	No	Ramp Slope (%)	10.4
No	Ramp Width (in)	35.5	Yes	Ramp XSlope (%)	0.7
N/A	Flare Type LT	N/A	N/A	Flare Type RT	N/A
N/A	Flare Slope LT (%)	N/A	N/A	Flare Slope RT (%)	N/A
N/A	Flare Traversable LT?	N/A	N/A	Flare Traversable RT?	N/A
N/A	Landing Length (in)	N/A	N/A	DWS Provided?	N/A
N/A	Landing Width (in)	N/A	N/A	DWS Contrast?	N/A
N/A	Landing Slope (%)	N/A	N/A	DWS Length (in)	N/A
N/A	Landing X Slope (%)	N/A	N/A	DWS Full Width?	N/A
N/A	Landing Curb? (Y/N)	N/A	N/A	DWS Offset (in)	N/A
N/A	Shared Landing?	N/A			
N/A	Gutter Ponding?	N/A	N/A	Gutter Slope (%)	N/A
N/A	Gutter Lip Ht (in)	N/A	N/A	Gutter X Slope (%)	N/A
N/A	Painted X Walk1?	No	N/A	Painted X Walk2?	No
	X Walk 1 Direction	To E		X Walk 2 Direction	To N
N/A	X Walk 1 Width (in)	N/A	N/A	X Walk 2 Width (in)	N/A
	X Walk 1 Slope (%)	0.6		X Walk 2 Slope (%)	3.8
	X Walk 1 X Slope (%)	2.4		X Walk 2 X Slope (%)	0.5

Remove & Replace Curb Ramp With Two New Directional Ramps or Equivalent.
