Access Compliance Report

Public Rights-of-Way

(Curb Ramps)

Intersection ID: 22977	Main Street: SOUTH_BV	Cross Street: MUSTANG_LN	Location: NE
ADA ID: 58098C75E7D3	Ramp Type: Perp	Initial Pass/Fail: Fail	Overall Compliance: No
		Severity Score: 8.75

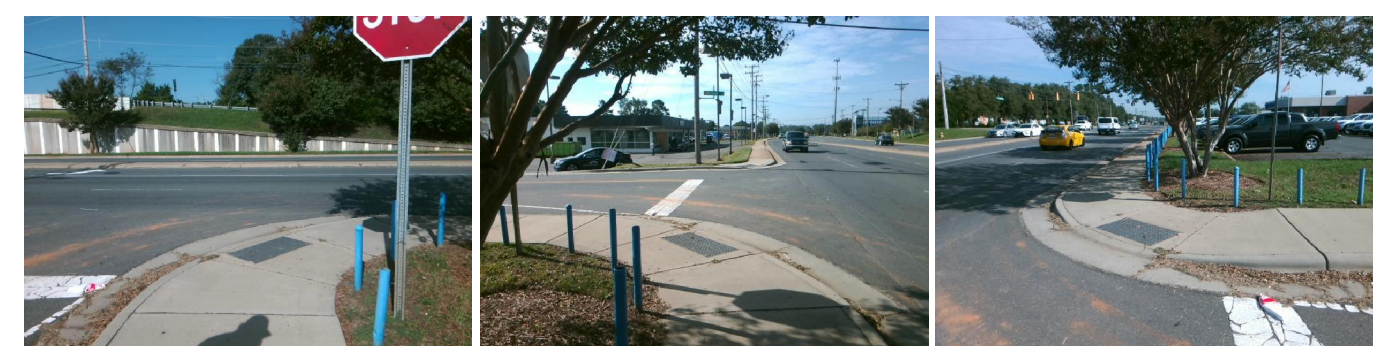
Possible Solutions:		Compliance	Description	Data
	Remove & Replace Entire Ramp.		N/A	Ramp Length (in)	71.0
			No	Ramp Width (in)	45.0
			N/A	Flare Type LT	N/A
			N/A	Flare Slope LT (%)	N/A
			N/A	Flare Traversable LT?	N/A
			N/A	Landing Length (in)	N/A
			N/A	Landing Width (in)	N/A
			N/A	Landing Slope (%)	N/A
			N/A	Landing X Slope (%)	N/A
<p>Surveyor Notes:</p> <p>N/A</p> <p>PROW/ADA:</p> <p>R304.5.1</p>			N/A	Flare Type RT	N/A
			N/A	Flare Slope RT (%)	N/A
			N/A	Flare Traversable RT?	N/A
			N/A	DWS Provided?	N/A
			N/A	DWS Contrast?	N/A
			N/A	DWS Length (in)	N/A
			N/A	DWS Full Width?	N/A
			N/A	DWS Offset (in)	N/A
			N/A	Shared Landing?	N/A
			N/A	Gutter Ponding?	N/A
			N/A	Gutter Lip Ht (in)	N/A
			N/A	Painted X Walk1?	No
				X Walk 1 Direction	To S
			N/A	X Walk 1 Width (in)	N/A
				X Walk 1 Slope (%)	0.7
				X Walk 1 X Slope (%)	1.9

N/A	Ramp inside XWalk1?	N/A
				Road Slope (%)	N/A
				Road X Slope (%)	N/A
			N/A	Any Obstructions?	N/A
				Obstruction Type	
Total Cost:		\$ 1850.00			
			N/A		N/A
			Yes	Surface Condition? (G/P)	Good
