# Access Compliance Report

## Public Rights-of-Way

### (Curb Ramps)

Intersection ID: 14278	Main Street: ROMARE_BEARDEN_DR	Cross Street: FARMER_ST	Location: E
ADA ID: 59DAC868D2C8	Ramp Type: MedianPerp	Initial Pass/Fail: Fail	Overall Compliance: No
Severity Score: 21.25			
Codes/Mitigation Info/Possible Solution		Field Measurements/Component Compliance

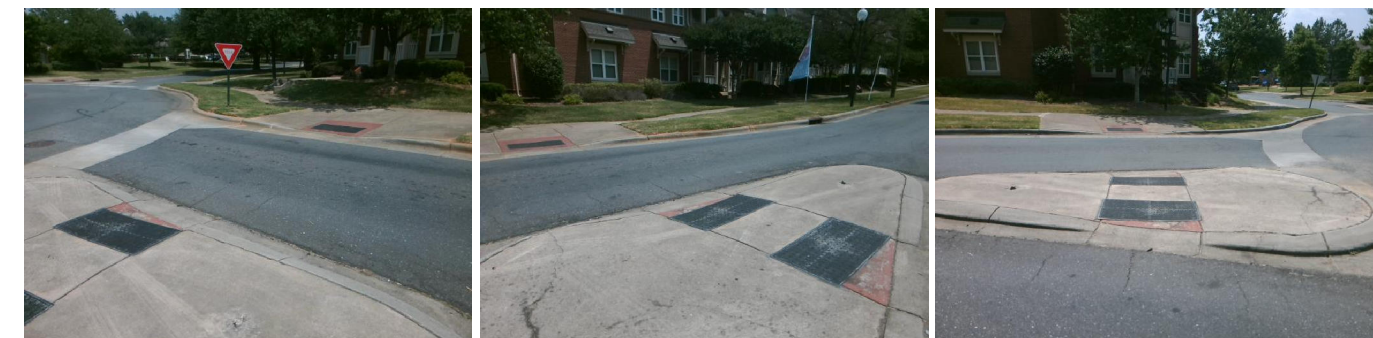
**Not Found, R304.5.1, R304.5.3**

Compliance	Description	Data	Compliance	Description	Data
N/A	Ramp Length (in)	39.0	Yes	Ramp Slope (%)	7.5
No	Ramp Width (in)	45.0	No	Ramp XSlope (%)	5.1
N/A	Flare Type LT	N/A	N/A	Flare Type RT	N/A
N/A	Flare Slope LT (%)	N/A	N/A	Flare Slope RT (%)	N/A
N/A	Flare Traversable LT?	N/A	N/A	Flare Traversable RT?	N/A
N/A	Landing Length (in)	N/A	N/A	DWS Provided?	N/A
N/A	Landing Width (in)	N/A	N/A	DWS Contrast?	N/A
N/A	Landing Slope (%)	N/A	N/A	DWS Length (in)	N/A
N/A	Landing X Slope (%)	N/A	N/A	DWS Full Width?	N/A
N/A	Landing Curb? (Y/N)	N/A	N/A	DWS Offset (in)	N/A
N/A	Shared Landing?	N/A			
N/A	Gutter Ponding?	N/A	N/A	Gutter Slope (%)	N/A
N/A	Gutter Lip Ht (in)	N/A	N/A	Gutter X Slope (%)	N/A
N/A	Painted X Walk1?	No	N/A	Painted X Walk2?	N/A
	X Walk 1 Direction	To N		X Walk 2 Direction	N/A
N/A	X Walk 1 Width (in)	N/A	N/A	X Walk 2 Width (in)	N/A
	X Walk 1 Slope (%)	0.8		X Walk 2 Slope (%)	N/A
	X Walk 1 X Slope (%)	3.5		X Walk 2 X Slope (%)	N/A

**Remove & Replace Entire Ramp.**
