# Access Compliance Report

## Public Rights-of-Way

| Intersection ID: 47136 | Main Street: DARLINGTON_RD | Cross Street: HABITAT_MANOR_DR | Location: SE |
| ADA ID: 5C3FC0F0A1FA | Ramp Type: PerpDiag | Initial Pass/Fail: Fail | Overall Compliance: No |

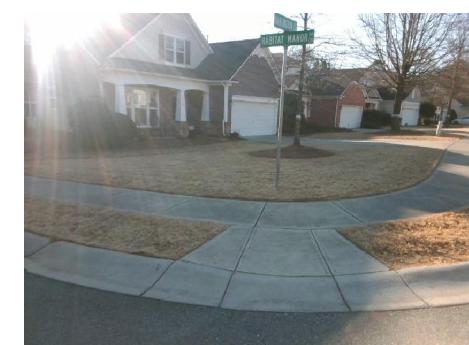
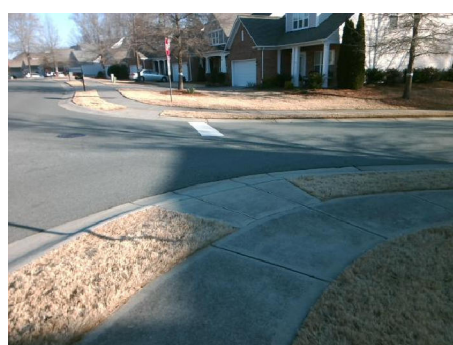
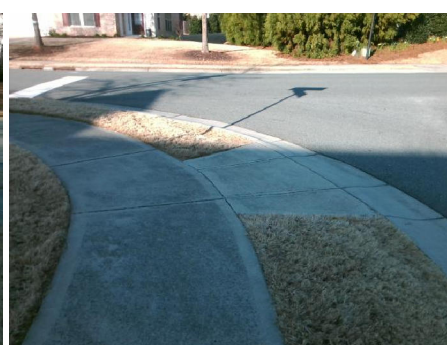
**Not Found, R304.5.1, R304.5.3**

| Compliance | Description | Data | Compliance | Description | Data |
|---|---|---|---|---|---|
| No | Ramp Width (in) | 30.0 | No | Ramp XSlope (%) | 3.2 |

**Remove & Replace Curb Ramp With Two New Directional Ramps or Equivalent.**
