Access Compliance Report

Public Rights-of-Way (Curb Ramps)

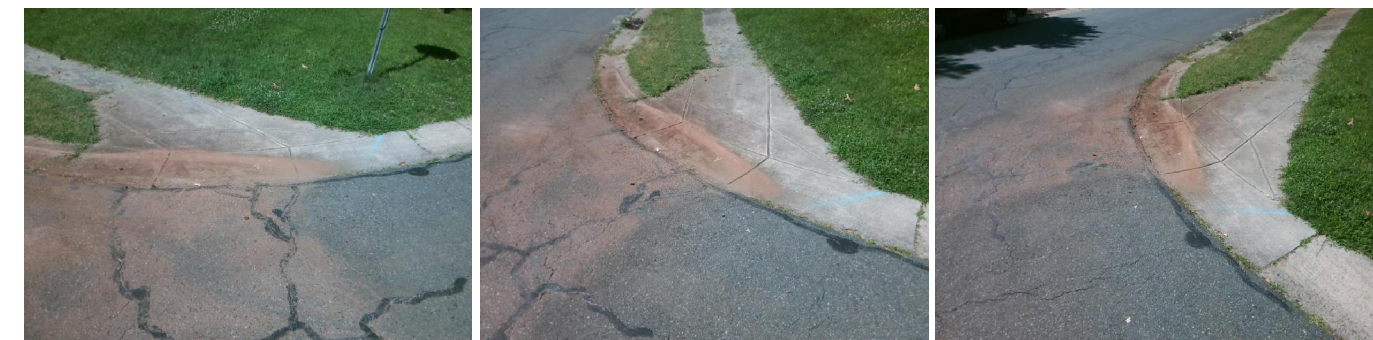
Intersection ID: 3889		Main Street: BICKHAM_LN		Cross Street: NEUHOFF_LN		Location: S											
ADA ID: 5CB645F3B032		Ramp Type: Directional1		Initial Pass/Fail: Fail		Overall Compliance: No		Severity Score: 25									
Codes/Mitigation Info/Possible Solution				Field Measurements/Component Compliance													
<div>

X Walk 1 X Slope (%)		4.1		N/A	Storm Grate/Utility Hazard?	N/A					
						N/A	Ramp inside XWalk1?	N/A		Storm Grate/Utility Type							
						N/A	Any Obstructions?	N/A				N/A					
						Obstruction Type				Yes	Surface Condition? (G/P)	Good					
										N/A	Curb Slope (%)	12.1
