Access Compliance Report

Public Rights-of-Way

(Curb Ramps)

Intersection ID: 7328	Main Street: MOORES_CHAPEL_RD	Cross Street: TILDEN_RD	Location:	E
ADA ID: 5CDD55C09C43	Ramp Type: Perp	Initial Pass/Fail: Fail	Overall Compliance: No	Severity Score: 18.75
Codes/Mitigation Info/Possible Solution		Field Measurements/Component Compliance

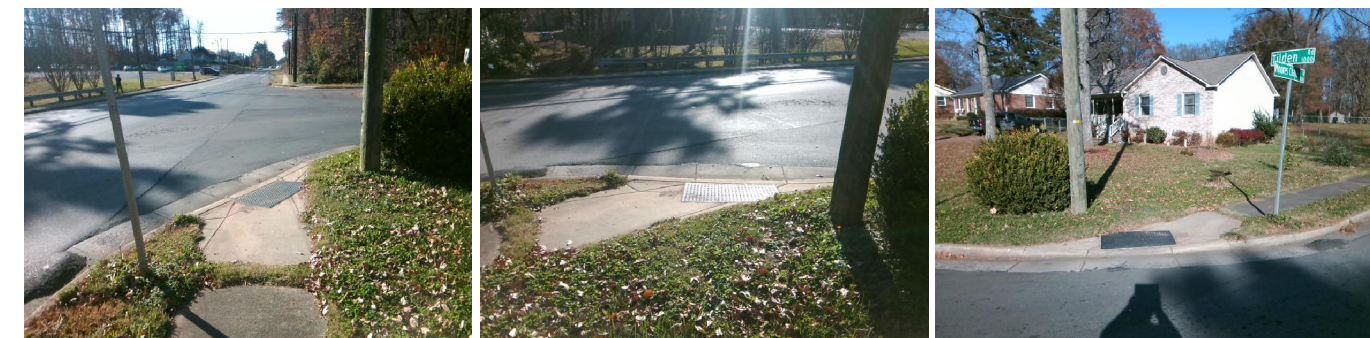
Not Found, R304.5.1, R304.5.3

Compliance	Description	Data	Compliance	Description	Data
N/A	Ramp Length (in)	43.0	Yes	Ramp Slope (%)	5.7
No	Ramp Width (in)	34.0	No	Ramp XSlope (%)	2.4
N/A	Flare Type LT	N/A	N/A	Flare Type RT	N/A
N/A	Flare Slope LT (%)	N/A	N/A	Flare Slope RT (%)	N/A
N/A	Flare Traversable LT?	N/A	N/A	Flare Traversable RT?	N/A
N/A	Landing Length (in)	N/A	N/A	DWS Provided?	N/A
N/A	Landing Width (in)	N/A	N/A	DWS Contrast?	N/A
N/A	Landing Slope (%)	N/A	N/A	DWS Length (in)	N/A
N/A	Landing X Slope (%)	N/A	N/A	DWS Full Width?	N/A
N/A	Landing Curb? (Y/N)	N/A	N/A	DWS Offset (in)	N/A
N/A	Shared Landing?	N/A			
N/A	Gutter Ponding?	N/A	N/A	Gutter Slope (%)	N/A
N/A	Gutter Lip Ht (in)	N/A	N/A	Gutter X Slope (%)	N/A
N/A	Painted X Walk1?	No	N/A	Painted X Walk2?	N/A
	X Walk 1 Direction	To W		X Walk 2 Direction	N/A
N/A	X Walk 1 Width (in)	N/A	N/A	X Walk 2 Width (in)	N/A
	X Walk 1 Slope (%)	1.5		X Walk 2 Slope (%)	N/A
	X Walk 1 X Slope (%)	2.6		X Walk 2 X Slope (%)	N/A

N/A	Ramp inside XWalk1?	N/A	N/A	Ramp inside XWalk2?	N/A
	Road Slope (%)	N/A	N/A	Clear Space?	N/A
	Road X Slope (%)	N/A	N/A	Clear Space to XWalk (in)	N/A
N/A	Any Obstructions?	N/A	N/A	Storm Grate/Utility Hazard?	N/A
	Obstruction Type			Storm Grate/Utility Type	
		N/A			N/A
			Yes	Surface Condition? (G/P)	Good

Remove & Replace Entire Ramp.
