Access Compliance Report

Public Rights-of-Way

(Curb Ramps)

Intersection ID: 10027108	Main Street: GANSO_LN	Cross Street: N/A	Location: SW
ADA ID: 5D3D0325BF3B	Ramp Type: Perp	Initial Pass/Fail: Fail	Overall Compliance: No
		Severity Score: 25

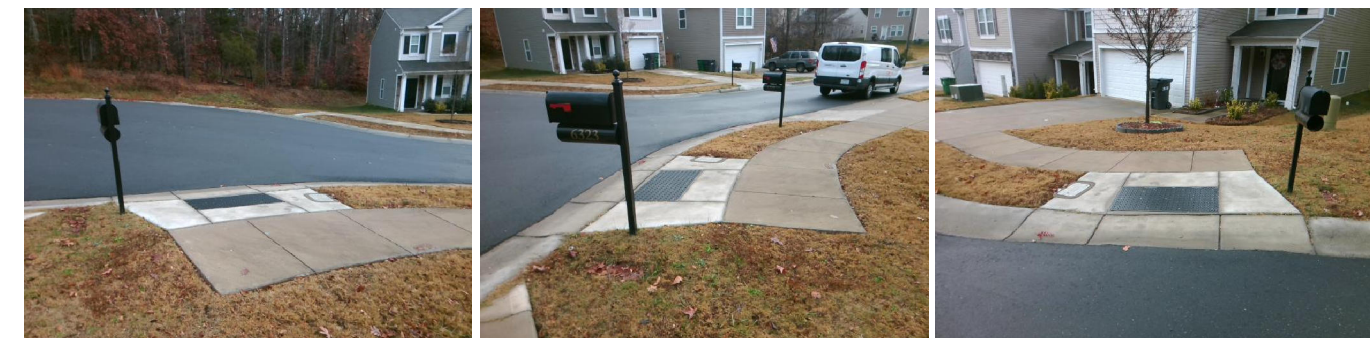
Not Found, R304.5.3

Compliance	Description	Data	Compliance	Description	Data
N/A	Ramp Length (in)	49.0	Yes	Ramp Slope (%)	6.9
Yes	Ramp Width (in)	48.0	No	Ramp XSlope (%)	7.3
N/A	Flare Type LT	N/A	N/A	Flare Type RT	N/A
N/A	Flare Slope LT (%)	N/A	N/A	Flare Slope RT (%)	N/A
N/A	Flare Traversable LT?	N/A	N/A	Flare Traversable RT?	N/A
N/A	Landing Length (in)	N/A	N/A	DWS Provided?	N/A
N/A	Landing Width (in)	N/A	N/A	DWS Contrast?	N/A
N/A	Landing Slope (%)	N/A	N/A	DWS Length (in)	N/A
N/A	Landing X Slope (%)	N/A	N/A	DWS Full Width?	N/A
N/A	Landing Curb? (Y/N)	N/A	N/A	DWS Offset (in)	N/A
N/A	Shared Landing?	N/A			
N/A	Gutter Ponding?	N/A	N/A	Gutter Slope (%)	N/A
N/A	Gutter Lip Ht (in)	N/A	N/A	Gutter X Slope (%)	N/A
N/A	Painted X Walk1?	No	N/A	Painted X Walk2?	N/A
	X Walk 1 Direction	To NE		X Walk 2 Direction	N/A
N/A	X Walk 1 Width (in)	N/A	N/A	X Walk 2 Width (in)	N/A
	X Walk 1 Slope (%)	3.4		X Walk 2 Slope (%)	N/A
	X Walk 1 X Slope (%)	9.9		X Walk 2 X Slope (%)	N/A

Remove & Replace Entire Ramp.
