Access Compliance Report

Public Rights-of-Way (Curb Ramps)

Intersection ID: 13795	Main Street: DENBUR_DR	Cross Street: LUSTERLEAF_HOLLY_RD	Location: S
ADA ID: 5D6C4449827B	Ramp Type: Perp	Initial Pass/Fail: Fail	Overall Compliance: No
Severity Score: 22.5			
Codes/Mitigation Info/Possible Solution		Field Measurements/Component Compliance

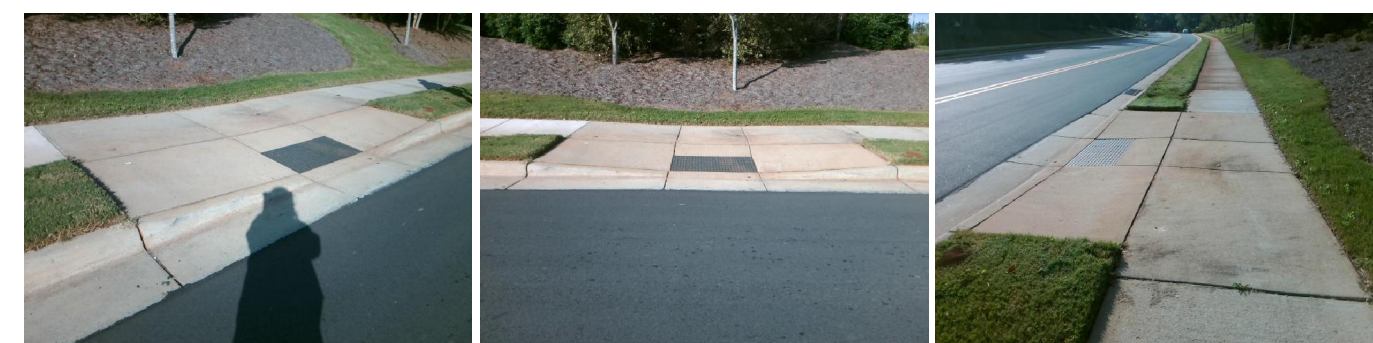
Not Found, R304.5.1, R304.2.2, R304.5.3

Compliance	Description	Data	Compliance	Description	Data
N/A	Ramp Length (in)	47.0	No	Ramp Slope (%)	9.9
No	Ramp Width (in)	47.0	No	Ramp XSlope (%)	3.8
N/A	Flare Type LT	N/A	N/A	Flare Type RT	N/A
N/A	Flare Slope LT (%)	N/A	N/A	Flare Slope RT (%)	N/A
N/A	Flare Traversable LT?	N/A	N/A	Flare Traversable RT?	N/A
N/A	Landing Length (in)	N/A	N/A	DWS Provided?	N/A
N/A	Landing Width (in)	N/A	N/A	DWS Contrast?	N/A
N/A	Landing Slope (%)	N/A	N/A	DWS Length (in)	N/A
N/A	Landing X Slope (%)	N/A	N/A	DWS Full Width?	N/A
N/A	Landing Curb? (Y/N)	N/A	N/A	DWS Offset (in)	N/A
N/A	Shared Landing?	N/A			
N/A	Gutter Ponding?	N/A	N/A	Gutter Slope (%)	N/A
N/A	Gutter Lip Ht (in)	N/A	N/A	Gutter X Slope (%)	N/A
N/A	Painted X Walk1?	No	N/A	Painted X Walk2?	N/A
	X Walk 1 Direction	To NE		X Walk 2 Direction	N/A
N/A	X Walk 1 Width (in)	N/A	N/A	X Walk 2 Width (in)	N/A
	X Walk 1 Slope (%)	2.4		X Walk 2 Slope (%)	N/A
	X Walk 1 X Slope (%)	3.2		X Walk 2 X Slope (%)	N/A

N/A	Ramp inside XWalk1?	N/A	N/A	Ramp inside XWalk2?	N/A
	Road Slope (%)	N/A	N/A	Clear Space?	N/A
	Road X Slope (%)	N/A	N/A	Clear Space to XWalk (in)	N/A
N/A	Any Obstructions?	N/A	N/A	Storm Grate/Utility Hazard?	N/A
	Obstruction Type			Storm Grate/Utility Type	
		N/A			N/A
			Yes	Surface Condition? (G/P)	Good

Remove & Replace Entire Ramp.
