# Access Compliance Report

## Public Rights-of-Way

### (Curb Ramps)

Intersection ID: 12388	Main Street: BERRYHILL_RD	Cross Street: GREENLAND_AV	Location: NE
ADA ID: 5E006A02A75A	Ramp Type: Combination1Diag	Initial Pass/Fail: Fail	Overall Compliance: No
		Severity Score: 0

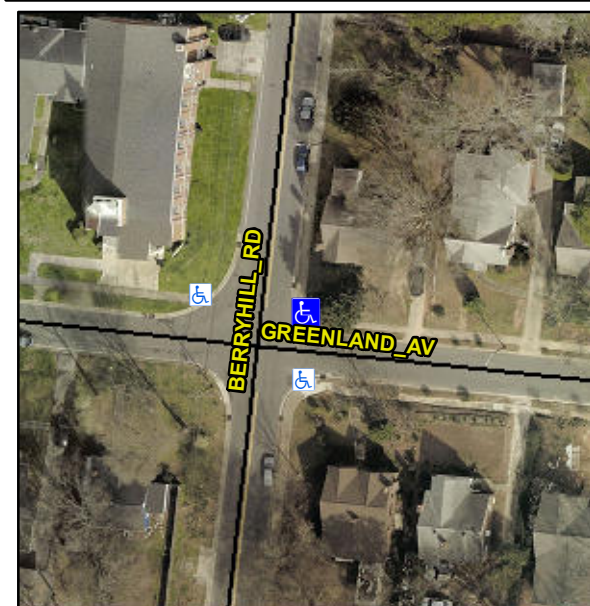
**RP & LT RP < 5%**

**Not Found, R304.5.1, R304.5.1, R304.5.3**

Compliance	Description	Data	Compliance	Description	Data
N/A	Ramp Length LT (in)	50.0	N/A	Ramp Length RT (in)	65.0
Yes	Ramp Width LT (in)	63.0	No	Ramp Width RT (in)	40.5
Yes	Ramp Slope LT (%)	1.9	Yes	Ramp Slope RT (%)	6.8
Yes	Ramp XSlope LT (%)	1.0	Yes	Ramp XSlope RT (%)	0.3
N/A	Ramp Length (in)	62.0	Yes	Ramp Slope (%)	0.3
No	Ramp Width (in)	40.5	No	Ramp XSlope (%)	4.0
N/A	Flare Type LT	N/A	N/A	Flare Type RT	N/A
N/A	Flare Slope LT (%)	N/A	N/A	Flare Slope RT (%)	N/A
N/A	Flare Traversable LT?	N/A	N/A	Flare Traversable RT?	N/A
N/A	Landing Length (in)	N/A	N/A	DWS Provided?	N/A
N/A	Landing Width (in)	N/A	N/A	DWS Contrast?	N/A
N/A	Landing Slope (%)	N/A	N/A	DWS Length (in)	N/A
N/A	Landing X Slope (%)	N/A	N/A	DWS Full Width?	N/A
N/A	Landing Curb? (Y/N)	N/A	N/A	DWS Offset (in)	N/A
N/A	Shared Landing?	N/A			
N/A	Gutter Ponding?	N/A	N/A	Gutter Slope (%)	N/A
N/A	Gutter Lip Ht (in)	N/A	N/A	Gutter X Slope (%)	N/A
N/A	Painted X Walk1?	No	N/A	Painted X Walk2?	No

**Remove & Replace Curb Ramp With Two New Directional Ramps or Equivalent.**
