Access Compliance Report

Public Rights-of-Way

(Curb Ramps)

Intersection ID: 48516	Main Street: GALLERIA CLUB LN	Cross Street: GALLERIA BV	Location: S
ADA ID: 5E7A8699B8E6	Ramp Type: PerpDiag	Initial Pass/Fail: Fail	Overall Compliance: No
Codes/Mitigation Info/Possible Solution		Field Measurements/Component Compliance	
Severity Score: 8.75

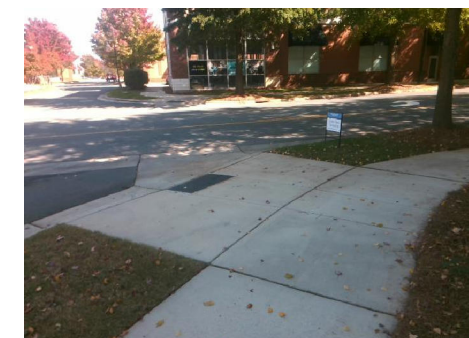
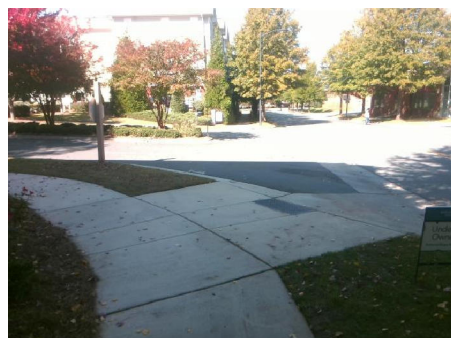
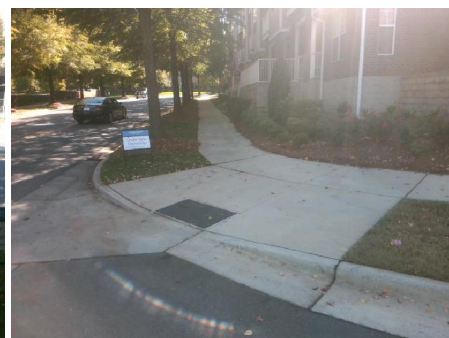
Not Found, R304.5.1

Compliance	Description	Data	Compliance	Description	Data
N/A	Ramp Length (in)	96.0	Yes	Ramp Slope (%)	7.0
No	Ramp Width (in)	39.0	Yes	Ramp XSlope (%)	0.6
N/A	Flare Type LT	N/A	N/A	Flare Type RT	N/A
N/A	Flare Slope LT (%)	N/A	N/A	Flare Slope RT (%)	N/A
N/A	Flare Traversable LT?	N/A	N/A	Flare Traversable RT?	N/A
N/A	Landing Length (in)	N/A	N/A	DWS Provided?	N/A
N/A	Landing Width (in)	N/A	N/A	DWS Contrast?	N/A
N/A	Landing Slope (%)	N/A	N/A	DWS Length (in)	N/A
N/A	Landing X Slope (%)	N/A	N/A	DWS Full Width?	N/A
N/A	Landing Curb? (Y/N)	N/A	N/A	DWS Offset (in)	N/A
N/A	Shared Landing?	N/A			
N/A	Gutter Ponding?	N/A	N/A	Gutter Slope (%)	N/A
N/A	Gutter Lip Ht (in)	N/A	N/A	Gutter X Slope (%)	N/A
N/A	Painted X Walk1?	No	N/A	Painted X Walk2?	No
	X Walk 1 Direction	To NE		X Walk 2 Direction	To NW
N/A	X Walk 1 Width (in)	N/A	N/A	X Walk 2 Width (in)	N/A
	X Walk 1 Slope (%)	3.5		X Walk 2 Slope (%)	1.8
	X Walk 1 X Slope (%)	0.9		X Walk 2 X Slope (%)	1.1

N/A	Ramp inside XWalk1?	N/A	N/A	Ramp inside XWalk2?	N/A
	Road Slope (%)	2.2	N/A	Clear Space?	N/A
	Road X Slope (%)	2.2	N/A	Clear Space to XWalk (in)	N/A
N/A	Any Obstructions?	N/A	N/A	Storm Grate/Utility Hazard?	N/A
	Obstruction Type			Storm Grate/Utility Type	
		N/A			N/A
			Yes	Surface Condition? (G/P)	Good

Remove & Replace Curb Ramp With Two New Directional Ramps or Equivalent.
