Access Compliance Report

Public Rights-of-Way

(Curb Ramps)

Intersection ID: 2889	Main Street: ALLNESS_GLEN_LN	Cross Street: HARBURN_FOREST_DR	Location: W
ADA ID: 5F05F5D30CEC	Ramp Type: PerpDiag	Initial Pass/Fail: Fail	Overall Compliance: No
Severity Score: 58.75			
Codes/Mitigation Info/Possible Solution		Field Measurements/Component Compliance

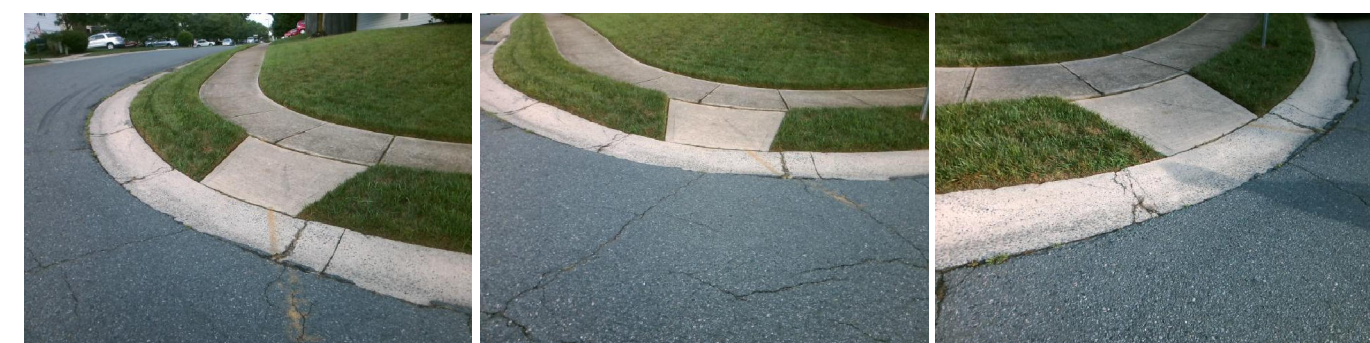
Not Found, R304.5.1, R304.2.2, R304.5.3

Compliance	Description	Data	Compliance	Description	Data
N/A	Ramp Length (in)	48.0	No	Ramp Slope (%)	15.0
No	Ramp Width (in)	47.5	No	Ramp XSlope (%)	8.0
N/A	Flare Type LT	N/A	N/A	Flare Type RT	N/A
N/A	Flare Slope LT (%)	N/A	N/A	Flare Slope RT (%)	N/A
N/A	Flare Traversable LT?	N/A	N/A	Flare Traversable RT?	N/A
N/A	Landing Length (in)	N/A	N/A	DWS Provided?	N/A
N/A	Landing Width (in)	N/A	N/A	DWS Contrast?	N/A
N/A	Landing Slope (%)	N/A	N/A	DWS Length (in)	N/A
N/A	Landing X Slope (%)	N/A	N/A	DWS Full Width?	N/A
N/A	Landing Curb? (Y/N)	N/A	N/A	DWS Offset (in)	N/A
N/A	Shared Landing?	N/A			
N/A	Gutter Ponding?	N/A	N/A	Gutter Slope (%)	N/A
N/A	Gutter Lip Ht (in)	N/A	N/A	Gutter X Slope (%)	N/A
N/A	Painted X Walk1?	No	N/A	Painted X Walk2?	No
	X Walk 1 Direction	To SE		X Walk 2 Direction	To NE
N/A	X Walk 1 Width (in)	N/A	N/A	X Walk 2 Width (in)	N/A
	X Walk 1 Slope (%)	11.9		X Walk 2 Slope (%)	0.1
	X Walk 1 X Slope (%)	5.0		X Walk 2 X Slope (%)	6.4

N/A	Ramp inside XWalk1?	N/A	N/A	Ramp inside XWalk2?	N/A
	Road Slope (%)	9.6	N/A	Clear Space?	N/A
	Road X Slope (%)	6.9	N/A	Clear Space to XWalk (in)	N/A
N/A	Any Obstructions?	N/A	N/A	Storm Grate/Utility Hazard?	N/A
	Obstruction Type			Storm Grate/Utility Type	
		N/A			N/A
			Yes	Surface Condition? (G/P)	Good

Remove & Replace Curb Ramp With Two New Directional Ramps or Equivalent.
