Access Compliance Report

Public Rights-of-Way

(Curb Ramps)

Intersection ID: 14278	Main Street: ROMARE_BEARDEN_DR	Cross Street: FARMER_ST	Location: NW
ADA ID: 5FB6682169FE	Ramp Type: Perp	Initial Pass/Fail: Fail	Overall Compliance: No
Severity Score: 13.75			
Codes/Mitigation Info/Possible Solution		Field Measurements/Component Compliance

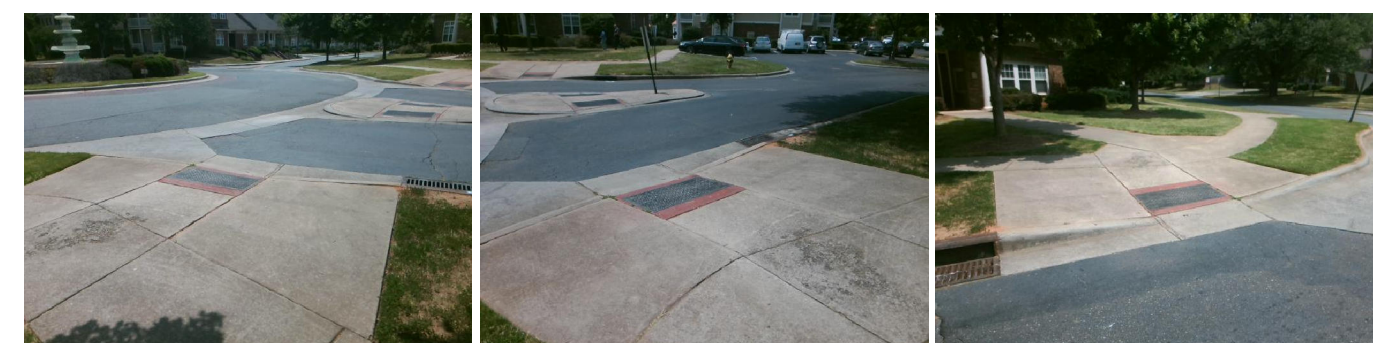
Compliance	Description	Data	Compliance	Description	Data
N/A	Ramp Length (in)	77.0	No	Ramp Slope (%)	9.1
Yes	Ramp Width (in)	50.0	No	Ramp XSlope (%)	3.7
N/A	Flare Type LT	N/A	N/A	Flare Type RT	N/A
N/A	Flare Slope LT (%)	N/A	N/A	Flare Slope RT (%)	N/A
N/A	Flare Traversable LT?	N/A	N/A	Flare Traversable RT?	N/A
N/A	Landing Length (in)	N/A	N/A	DWS Provided?	N/A
N/A	Landing Width (in)	N/A	N/A	DWS Contrast?	N/A
N/A	Landing Slope (%)	N/A	N/A	DWS Length (in)	N/A
N/A	Landing X Slope (%)	N/A	N/A	DWS Full Width?	N/A
N/A	Landing Curb? (Y/N)	N/A	N/A	DWS Offset (in)	N/A
N/A	Shared Landing?	N/A			
N/A	Gutter Ponding?	N/A	N/A	Gutter Slope (%)	N/A
N/A	Gutter Lip Ht (in)	N/A	N/A	Gutter X Slope (%)	N/A
N/A	Painted X Walk1?	No	N/A	Painted X Walk2?	N/A
	X Walk 1 Direction	To S		X Walk 2 Direction	N/A
N/A	X Walk 1 Width (in)	N/A	N/A	X Walk 2 Width (in)	N/A
	X Walk 1 Slope (%)	1.3		X Walk 2 Slope (%)	N/A
	X Walk 1 X Slope (%)	0.7		X Walk 2 X Slope (%)	N/A

N/A	Ramp inside XWalk1?	N/A	N/A	Ramp inside XWalk2?	N/A
	Road Slope (%)	N/A	N/A	Clear Space?	N/A
	Road X Slope (%)	N/A	N/A	Clear Space to XWalk (in)	N/A
N/A	Any Obstructions?	N/A	N/A	Storm Grate/Utility Hazard?	N/A
	Obstruction Type			Storm Grate/Utility Type	
		N/A			N/A
			Yes	Surface Condition? (G/P)	Good

Remove & Replace Entire Ramp.
