# Access Compliance Report

## Public Rights-of-Way

| Intersection ID: 42489 | Main Street: ALEXANDER MARTIN AV | Cross Street: LINA ARDREY LN | Location: NE |
| ADA ID: 5FDACAFCD0B3 | Ramp Type: Combination1Diag | Initial Pass/Fail: Fail | Overall Compliance: No |

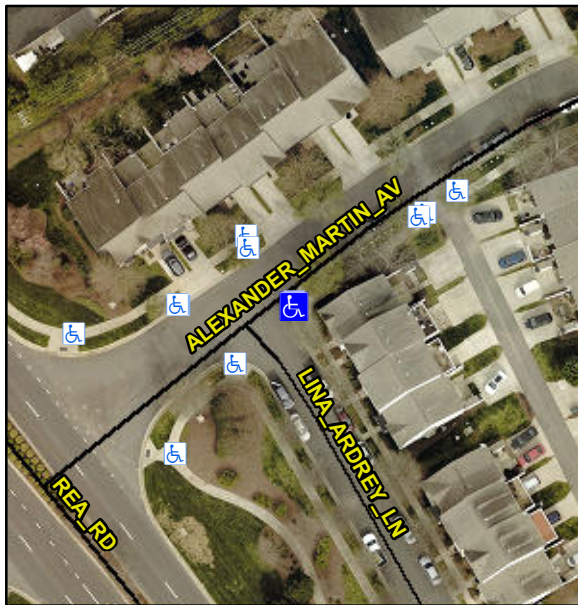
**RP & RT RP < 5%**

**R304.5.1, R304.5.3**

| Compliance | Description | Data | Compliance | Description | Data |
|---|---|---|---|---|---|
| No | Ramp XSlope LT (%) | 2.6 | No | Ramp XSlope RT (%) | 2.6 |
| No | Ramp Width (in) | 37.0 | No | Ramp XSlope (%) | 4.5 |

**Remove & Replace Curb Ramp With Two New Directional Ramps or Equivalent.**
