# Access Compliance Report

## Public Rights-of-Way

### (Curb Ramps)

| Intersection ID: 50321 | Main Street: BELMAR_PLACE_RD | Cross Street: CINDY_LN | Location: SE |

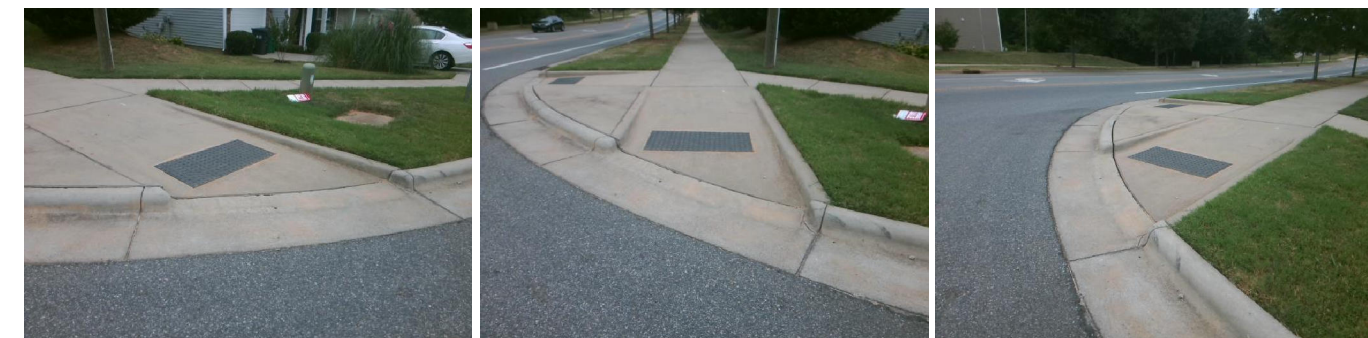
**Not Found, R305.1.4, R305.2,  
R302.7.2, R304.5.3**

| Compliance | Description | Data | Compliance | Description | Data |
|---|---|---|---|---|---|
| Yes | Landing X Slope (%) | 0.9 | No | DWS Full Width? | No |

**Remove & Replace Entire Ramp.  
Remove & Replace Gutter.**
