Access Compliance Report

Public Rights-of-Way

(Curb Ramps)

Intersection ID: 30131	Main Street: WADENA_DR	Cross Street: HARLAND_ST	Location: SW
ADA ID: 607BAD53BC92	Ramp Type: PerpDiag	Initial Pass/Fail: Fail	Overall Compliance: No
Severity Score: 12.5			
Codes/Mitigation Info/Possible Solution		Field Measurements/Component Compliance

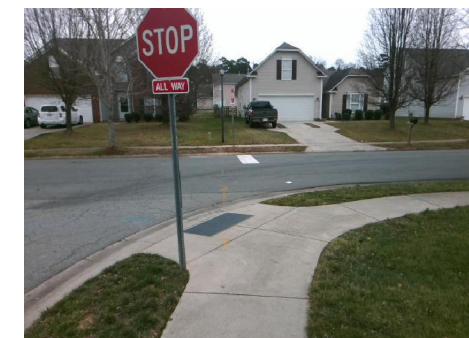
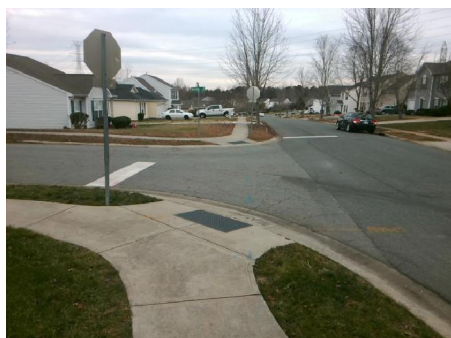
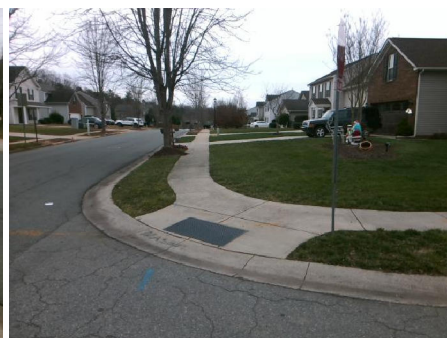
Not Found, R304.2.2

Compliance	Description	Data	Compliance	Description	Data
N/A	Ramp Length (in)	42.0	No	Ramp Slope (%)	8.6
Yes	Ramp Width (in)	48.0	Yes	Ramp XSlope (%)	1.6
N/A	Flare Type LT	N/A	N/A	Flare Type RT	N/A
N/A	Flare Slope LT (%)	N/A	N/A	Flare Slope RT (%)	N/A
N/A	Flare Traversable LT?	N/A	N/A	Flare Traversable RT?	N/A
N/A	Landing Length (in)	N/A	N/A	DWS Provided?	N/A
N/A	Landing Width (in)	N/A	N/A	DWS Contrast?	N/A
N/A	Landing Slope (%)	N/A	N/A	DWS Length (in)	N/A
N/A	Landing X Slope (%)	N/A	N/A	DWS Full Width?	N/A
N/A	Landing Curb? (Y/N)	N/A	N/A	DWS Offset (in)	N/A
N/A	Shared Landing?	N/A			
N/A	Gutter Ponding?	N/A	N/A	Gutter Slope (%)	N/A
N/A	Gutter Lip Ht (in)	N/A	N/A	Gutter X Slope (%)	N/A
N/A	Painted X Walk1?	No	N/A	Painted X Walk2?	No
	X Walk 1 Direction	To E		X Walk 2 Direction	To N
N/A	X Walk 1 Width (in)	N/A	N/A	X Walk 2 Width (in)	N/A
	X Walk 1 Slope (%)	1.4		X Walk 2 Slope (%)	2.8
	X Walk 1 X Slope (%)	0.8		X Walk 2 X Slope (%)	0.4

N/A	Ramp inside XWalk1?	N/A	N/A	Ramp inside XWalk2?	N/A
	Road Slope (%)	0.6	N/A	Clear Space?	N/A
	Road X Slope (%)	0.5	N/A	Clear Space to XWalk (in)	N/A
N/A	Any Obstructions?	N/A	N/A	Storm Grate/Utility Hazard?	N/A
	Obstruction Type			Storm Grate/Utility Type	
		N/A			N/A
		Yes		Surface Condition? (G/P)	Good

Remove & Replace Curb Ramp With Two New Directional Ramps or Equivalent.
