# Access Compliance Report

## Public Rights-of-Way

### (Curb Ramps)

Intersection ID: 45513	Main Street: FIRST_BLOOM_RD	Cross Street: HEDGEROW_PARK_RD	Location: S
ADA ID: 60B997BF68B7	Ramp Type: PerpDiag	Initial Pass/Fail: Fail	Overall Compliance: No
Severity Score: 36.25			
Codes/Mitigation Info/Possible Solution		Field Measurements/Component Compliance

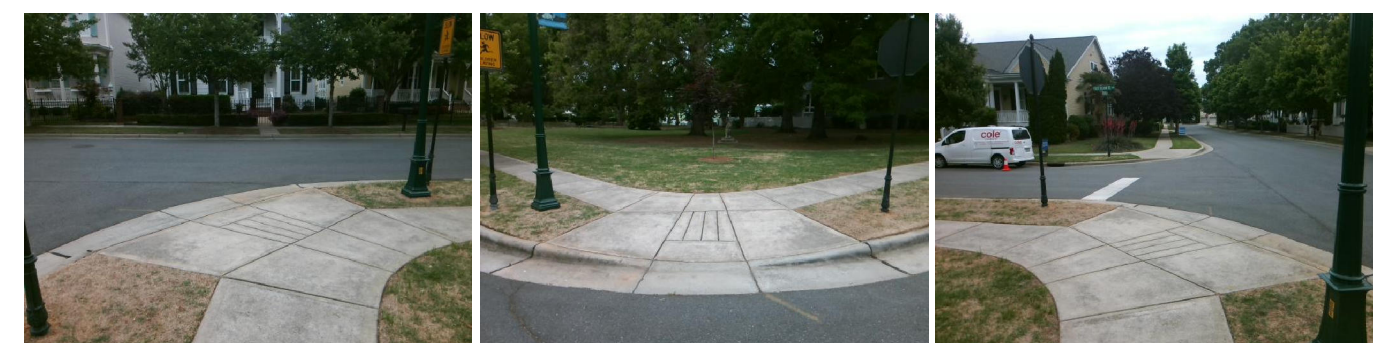
**Not Found, R304.5.1, R304.5.3**

Compliance	Description	Data	Compliance	Description	Data
N/A	Ramp Length (in)	71.0	Yes	Ramp Slope (%)	6.7
No	Ramp Width (in)	31.0	No	Ramp XSlope (%)	4.2
N/A	Flare Type LT	N/A	N/A	Flare Type RT	N/A
N/A	Flare Slope LT (%)	N/A	N/A	Flare Slope RT (%)	N/A
N/A	Flare Traversable LT?	N/A	N/A	Flare Traversable RT?	N/A
N/A	Landing Length (in)	N/A	N/A	DWS Provided?	N/A
N/A	Landing Width (in)	N/A	N/A	DWS Contrast?	N/A
N/A	Landing Slope (%)	N/A	N/A	DWS Length (in)	N/A
N/A	Landing X Slope (%)	N/A	N/A	DWS Full Width?	N/A
N/A	Landing Curb? (Y/N)	N/A	N/A	DWS Offset (in)	N/A
N/A	Shared Landing?	N/A			
N/A	Gutter Ponding?	N/A	N/A	Gutter Slope (%)	N/A
N/A	Gutter Lip Ht (in)	N/A	N/A	Gutter X Slope (%)	N/A
N/A	Painted X Walk1?	No	N/A	Painted X Walk2?	No
	X Walk 1 Direction	To NE		X Walk 2 Direction	To NW
N/A	X Walk 1 Width (in)	N/A	N/A	X Walk 2 Width (in)	N/A
	X Walk 1 Slope (%)	3.3		X Walk 2 Slope (%)	5.2
	X Walk 1 X Slope (%)	2.7		X Walk 2 X Slope (%)	1.2

N/A	Ramp inside XWalk1?	N/A	N/A	Ramp inside XWalk2?	N/A
	Road Slope (%)	1.6	N/A	Clear Space?	N/A
	Road X Slope (%)	3.2	N/A	Clear Space to XWalk (in)	N/A
N/A	Any Obstructions?	N/A	N/A	Storm Grate/Utility Hazard?	N/A
	Obstruction Type			Storm Grate/Utility Type	
		N/A			N/A
			Yes	Surface Condition? (G/P)	Good

**Remove & Replace Curb Ramp With Two New Directional Ramps or Equivalent.**
