# Access Compliance Report

## Public Rights-of-Way

### (Curb Ramps)

Intersection ID: 23633	Main Street: HILLSIDE_LN	Cross Street: LARRISA_CT	Location: NW
ADA ID: 61A8C9043692	Ramp Type: PerpDiag	Initial Pass/Fail: Fail	Overall Compliance: No
		Severity Score: 10

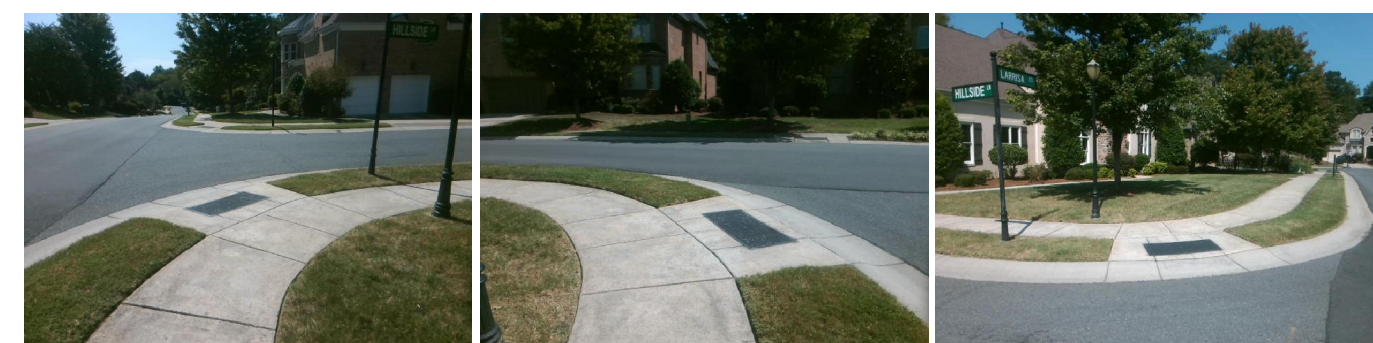
<b>N/A</b>	Ramp inside XWalk1?	N/A
<p>PROW/ADA:</p> <p><b>Not Found, R304.5.1, R304.5.3</b></p>			<b>1.4</b>	Road Slope (%)	N/A
			<b>3.0</b>	Road X Slope (%)	N/A
			<b>N/A</b>	Any Obstructions?	N/A
				Obstruction Type	N/A
			<b>N/A</b>		N/A
			<b>Yes</b>	Surface Condition? (G/P)	Good
Total Cost:		\$ 3200.00

Possible Solutions:		<b>Compliance</b>	<b>Description</b>	<b>Data</b>
	<b>Remove &amp; Replace Curb Ramp With Two New Directional Ramps or Equivalent.</b>		<b>Yes</b>	Ramp Length (in)	96.0
			<b>No</b>	Ramp Width (in)	37.0
			<b>N/A</b>	Flare Type LT	N/A
			<b>N/A</b>	Flare Slope LT (%)	N/A
			<b>N/A</b>	Flare Traversable LT?	N/A
			<b>N/A</b>	Landing Length (in)	N/A
			<b>N/A</b>	Landing Width (in)	N/A
			<b>N/A</b>	Landing Slope (%)	N/A
			<b>N/A</b>	Landing X Slope (%)	N/A
<p>Surveyor Notes:</p> <p><b>N/A</b></p>			<b>N/A</b>	Landing Curb? (Y/N)	N/A
			<b>N/A</b>	Shared Landing?	N/A
			<b>N/A</b>	Gutter Ponding?	N/A
			<b>N/A</b>	Gutter Lip Ht (in)	N/A
			<b>No</b>	Painted X Walk1?	N/A
			<b>To S</b>	X Walk 1 Direction	N/A
			<b>N/A</b>	X Walk 1 Width (in)	N/A
			<b>3.5</b>	X Walk 1 Slope (%)	N/A
			<b>2.2</b>	X Walk 1 X Slope (%)	N/A
