Access Compliance Report

Public Rights-of-Way

(Curb Ramps)

| Intersection ID: 44910 | Main Street: FOX_POINT_DR | Cross Street: OAKBURN_DR | Location: SE |

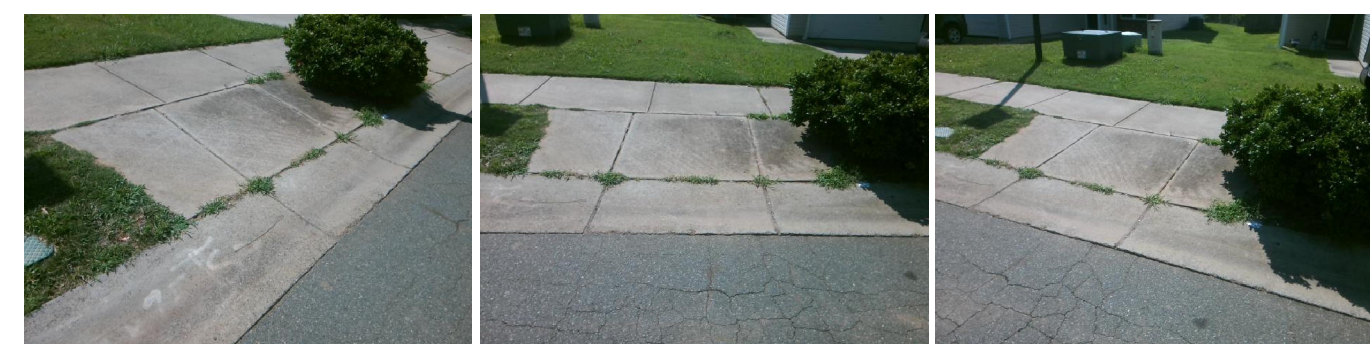
Not Found, R304.5.1, R304.2.2

| Compliance | Description | Data | Compliance | Description | Data |
|---|---|---|---|---|---|
| N/A | Ramp Length (in) | 47.5 | No | Ramp Slope (%) | 10.5 |
| No | Ramp Width (in) | 46.5 | Yes | Ramp XSlope (%) | 1.1 |

Remove & Replace Entire Ramp.
