Access Compliance Report

Public Rights-of-Way

(Curb Ramps)

Intersection ID: 45634	Main Street: LAKE_RD	Cross Street: MOLLY_ELIZABETH_LN	Location: SE
ADA ID: 630ECD9B5D12	Ramp Type: Perp	Initial Pass/Fail: Fail	Overall Compliance: No
Severity Score: 30			
Codes/Mitigation Info/Possible Solution		Field Measurements/Component Compliance

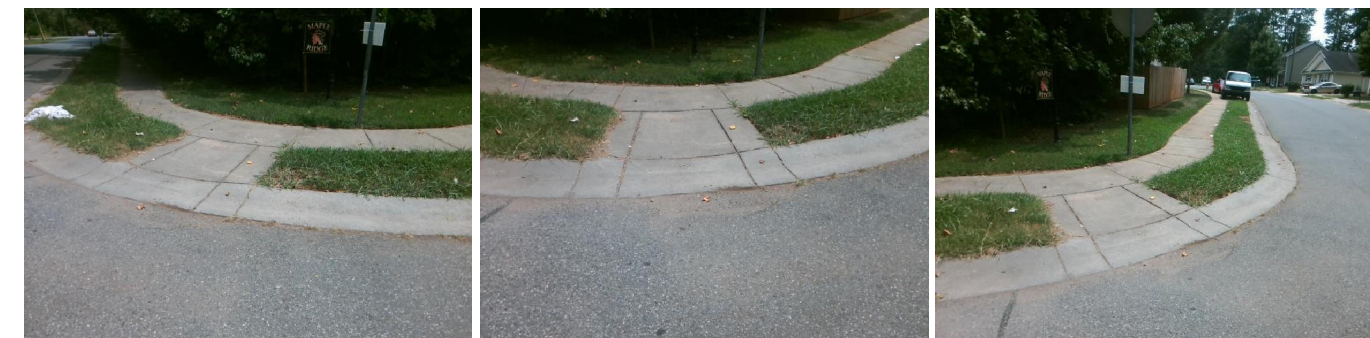
Not Found, R304.5.1, R304.2.2

Compliance	Description	Data	Compliance	Description	Data
N/A	Ramp Length (in)	48.0	No	Ramp Slope (%)	8.5
No	Ramp Width (in)	34.5	Yes	Ramp XSlope (%)	0.4
N/A	Flare Type LT	N/A	N/A	Flare Type RT	N/A
N/A	Flare Slope LT (%)	N/A	N/A	Flare Slope RT (%)	N/A
N/A	Flare Traversable LT?	N/A	N/A	Flare Traversable RT?	N/A
N/A	Landing Length (in)	N/A	N/A	DWS Provided?	N/A
N/A	Landing Width (in)	N/A	N/A	DWS Contrast?	N/A
N/A	Landing Slope (%)	N/A	N/A	DWS Length (in)	N/A
N/A	Landing X Slope (%)	N/A	N/A	DWS Full Width?	N/A
N/A	Landing Curb? (Y/N)	N/A	N/A	DWS Offset (in)	N/A
N/A	Shared Landing?	N/A			
N/A	Gutter Ponding?	N/A	N/A	Gutter Slope (%)	N/A
N/A	Gutter Lip Ht (in)	0.75	N/A	Gutter X Slope (%)	N/A
N/A	Painted X Walk1?	No	N/A	Painted X Walk2?	N/A
	X Walk 1 Direction	To W		X Walk 2 Direction	N/A
N/A	X Walk 1 Width (in)	N/A	N/A	X Walk 2 Width (in)	N/A
	X Walk 1 Slope (%)	1.0		X Walk 2 Slope (%)	N/A
	X Walk 1 X Slope (%)	0.8		X Walk 2 X Slope (%)	N/A

N/A	Ramp inside XWalk1?	N/A	N/A	Ramp inside XWalk2?	N/A
	Road Slope (%)	N/A	N/A	Clear Space?	N/A
	Road X Slope (%)	N/A	N/A	Clear Space to XWalk (in)	N/A
N/A	Any Obstructions?	N/A	N/A	Storm Grate/Utility Hazard?	N/A
	Obstruction Type			Storm Grate/Utility Type	
		N/A			N/A
			Yes	Surface Condition? (G/P)	Good

Remove & Replace Entire Ramp.
