Access Compliance Report

Public Rights-of-Way

| Intersection ID: 17902 | Main Street: MONROE_RD | Cross Street: CONFERENCE_DR | Location: SE |
| ADA ID: 63AEEF218143 | Ramp Type: Perp | Initial Pass/Fail: Fail | Overall Compliance: No |

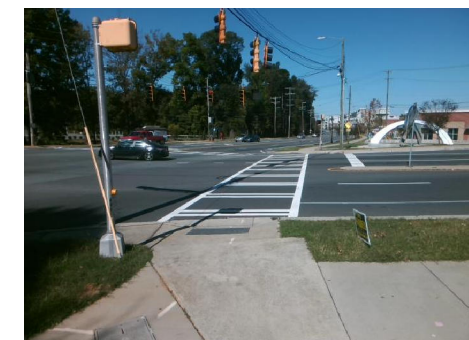
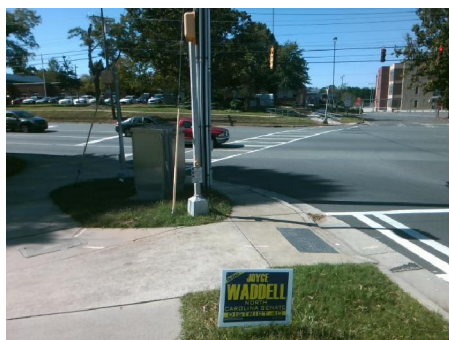
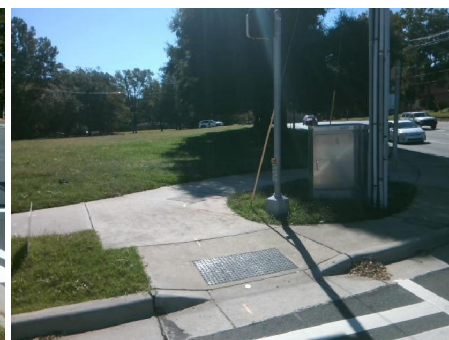
Not Found, R304.2.2, R304.5.3

| Compliance | Description | Data | Compliance | Description | Data |
|---|---|---|---|---|---|
| N/A | Ramp Length (in) | 52.0 | No | Ramp Slope (%) | 11.5 |
| Yes | Ramp Width (in) | 48.0 | No | Ramp XSlope (%) | 5.8 |

Possible Solutions:

Remove & Replace Entire Ramp.
