Access Compliance Report

Public Rights-of-Way

(Curb Ramps)

Intersection ID: 13612	Main Street: MORNINGSIDE_DR	Cross Street: LYON_CT	Location: SW
ADA ID: 64A86E3C4F66	Ramp Type: Perp	Initial Pass/Fail: Fail	Overall Compliance: No
		Severity Score: 22.5

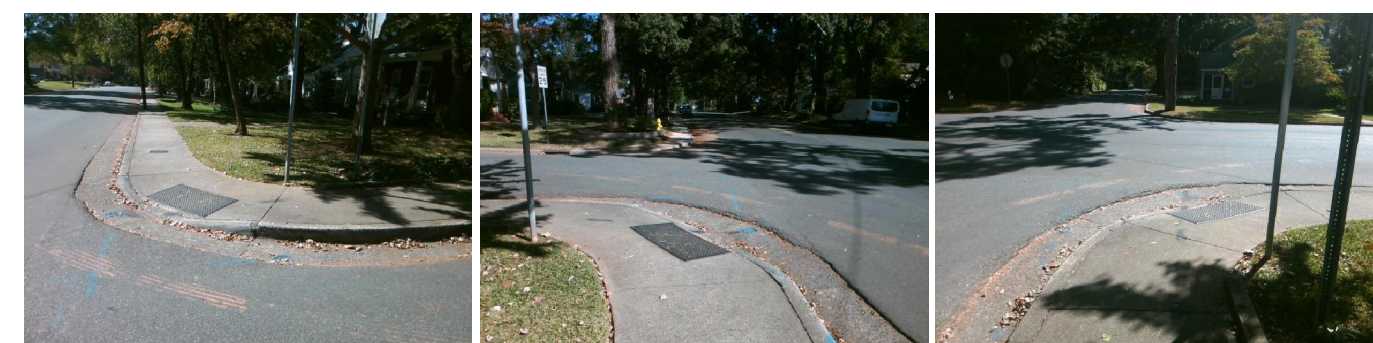
Possible Solutions:		Compliance	Description	Data
	Remove & Replace Entire Ramp.		No	Ramp Length (in)	60.0
			No	Ramp Width (in)	40.0
			N/A	Flare Type LT	N/A
			N/A	Flare Slope LT (%)	N/A
			N/A	Flare Traversable LT?	N/A
			N/A	Landing Length (in)	N/A
			N/A	Landing Width (in)	N/A
			N/A	Landing Slope (%)	N/A
			N/A	Landing X Slope (%)	N/A
<p>Surveyor Notes:</p> <p>N/A</p> <p>PROW/ADA:</p> <p>R304.5.1, R304.2.2, R304.5.3</p>			N/A	Flare Type RT	N/A
			N/A	Flare Slope RT (%)	N/A
			N/A	Flare Traversable RT?	N/A
			N/A	DWS Provided?	N/A
			N/A	DWS Contrast?	N/A
			N/A	DWS Length (in)	N/A
			N/A	DWS Full Width?	N/A
			N/A	DWS Offset (in)	N/A
			N/A	Gutter Ponding?	N/A
			N/A	Gutter Lip Ht (in)	3.0
			No	Painted X Walk1?	N/A
				X Walk 1 Direction	To N
			N/A	X Walk 1 Width (in)	N/A
				X Walk 1 Slope (%)	5.6
				X Walk 1 X Slope (%)	0.2

N/A	Ramp inside XWalk1?	N/A
			N/A	Road Slope (%)	N/A
			N/A	Road X Slope (%)	N/A
			N/A	Any Obstructions?	N/A
				Obstruction Type	
Total Cost: \$ 1850.00			N/A	Storm Grate/Utility Hazard?	N/A
			N/A	Storm Grate/Utility Type	N/A
			Yes	Surface Condition? (G/P)	Good
