Access Compliance Report

Public Rights-of-Way

(Curb Ramps)

Intersection ID: 6727	Main Street: MILAN_RD_EAST	Cross Street: BRADEN_DR	Location: S
ADA ID: 6570FEBA64E8	Ramp Type: Perpendicular	Initial Pass/Fail: Fail	Overall Compliance: No
		Severity Score: 25

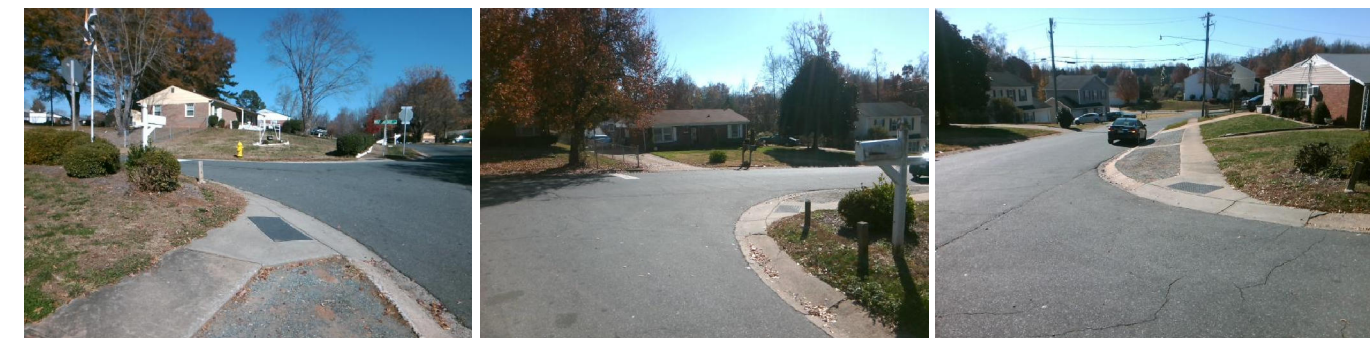
Not Found, R304.5.3

Compliance	Description	Data	Compliance	Description	Data
N/A	Ramp Length (in)	38.0	Yes	Ramp Slope (%)	8.1
Yes	Ramp Width (in)	48.0	No	Ramp XSlope (%)	14.1
N/A	Flare Type LT	N/A	N/A	Flare Type RT	N/A
N/A	Flare Slope LT (%)	N/A	N/A	Flare Slope RT (%)	N/A
N/A	Flare Traversable LT?	N/A	N/A	Flare Traversable RT?	N/A
N/A	Landing Length (in)	N/A	N/A	DWS Provided?	N/A
N/A	Landing Width (in)	N/A	N/A	DWS Contrast?	N/A
N/A	Landing Slope (%)	N/A	N/A	DWS Length (in)	N/A
N/A	Landing X Slope (%)	N/A	N/A	DWS Full Width?	N/A
N/A	Landing Curb? (Y/N)	N/A	N/A	DWS Offset (in)	N/A
N/A	Shared Landing?	N/A			
N/A	Gutter Ponding?	N/A	N/A	Gutter Slope (%)	N/A
N/A	Gutter Lip Ht (in)	N/A	N/A	Gutter X Slope (%)	N/A
N/A	Painted X Walk1?	No	N/A	Painted X Walk2?	N/A
	X Walk 1 Direction	To NE		X Walk 2 Direction	N/A
N/A	X Walk 1 Width (in)	N/A	N/A	X Walk 2 Width (in)	N/A
	X Walk 1 Slope (%)	11.6		X Walk 2 Slope (%)	N/A
	X Walk 1 X Slope (%)	1.5		X Walk 2 X Slope (%)	N/A

N/A	Ramp inside XWalk1?	N/A	N/A	Ramp inside XWalk2?	N/A
	Road Slope (%)	N/A	N/A	Clear Space?	N/A
	Road X Slope (%)	N/A	N/A	Clear Space to XWalk (in)	N/A
N/A	Any Obstructions?	N/A	N/A	Storm Grate/Utility Hazard?	N/A
	Obstruction Type			Storm Grate/Utility Type	
		N/A			N/A
			Yes	Surface Condition? (G/P)	Good

Remove & Replace Entire Ramp.
