# Access Compliance Report

## Public Rights-of-Way

### (Curb Ramps)

| Intersection ID: 8757 | | Main Street: JENNINGS_ST | | Cross Street: NEWCASTLE_ST | | Location: S | | | | | | | | | | | |

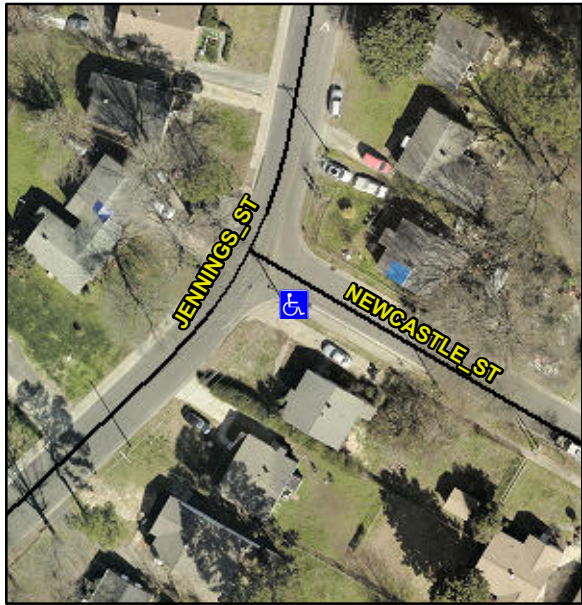
| | | | | | | No | Landing Length (in) | 37.0 | | Yes | DWS Provided? | Yes | | | | | |
| N/A | Shared Landing? | No | | | | No | DWS Offset RT (in) | 80.0 | | | | | | | | | |
| Yes | Gutter Lip Ht (in) | 0.0 | | | | No | Gutter X Slope (%) | 2.5 | | | | | | | | | |
| PROW/ADA:<br><br>Not Found, R304.2.1, R305.2, R304.5.3 | | N/A | Painted X Walk1? | No | | | Road Slope (%) | 5.6 | | | | | | | | | |

| | | | | Remove & Replace Entire Ramp.<br>Remove & Replace Gutter. | | N/A | Ramp Length (in) | 49.5 | | Yes | Grade Break? | Yes | | | | | |
