Access Compliance Report

Public Rights-of-Way

(Curb Ramps)

Intersection ID: 14023	Main Street: NORWICH_PL	Cross Street: CHELVESTON_DR	Location: SW
ADA ID: 65B17575F056	Ramp Type: Combination2Diag	Initial Pass/Fail: Pass	Overall Compliance: No
		Severity Score: 2.5

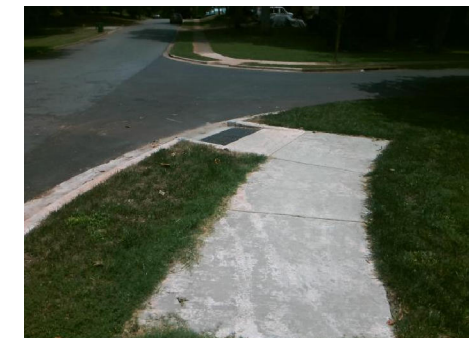
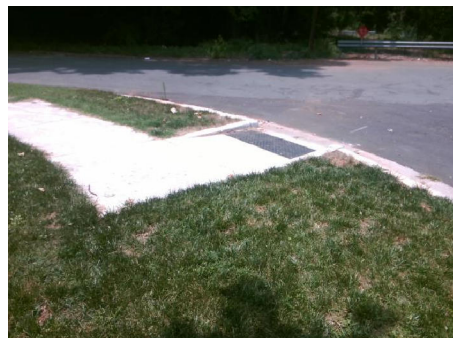
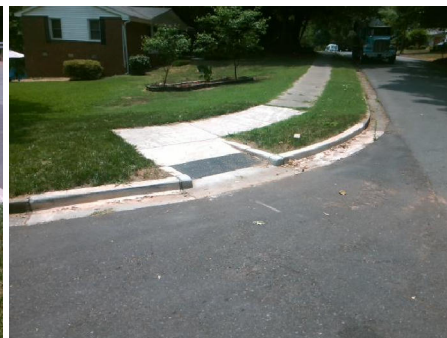
DWS WARPED

Not Found, R304.5.3, R305.1.4

Remove & Replace Curb Ramp With Two New Directional Ramps or Equivalent. Remove & Replace Gutter.
