Intersection ID: 12215	Main Street: MIDLAND_AV	Cross Street: DAVIS_AV	Location:	SW
ADA ID: 67C6D97BE36C	Ramp Type: Perp	Initial Pass/Fail: Fail	Overall Compliance: No	Severity Score: 26.25

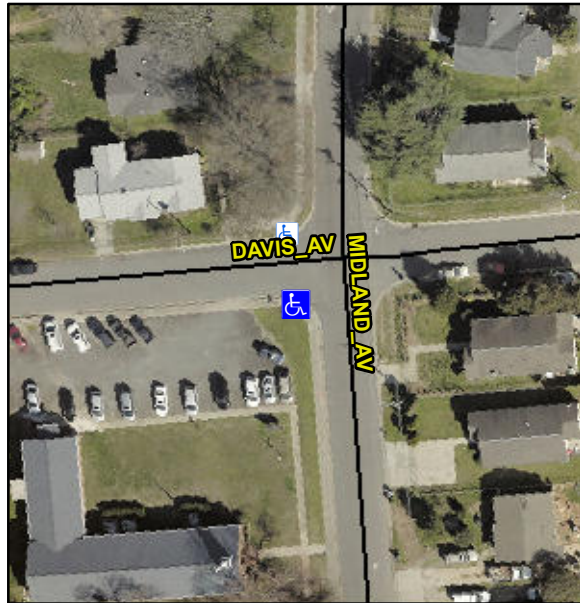
Not Found, R304.2.2, R304.5.3

Compliance	Description	Data	Compliance	Description	Data
N/A	Ramp Length (in)	48.0	No	Ramp Slope (%)	13.3
Yes	Ramp Width (in)	48.0	No	Ramp XSlope (%)	4.4
N/A	Flare Type LT	N/A	N/A	Flare Type RT	N/A
N/A	Flare Slope LT (%)	N/A	N/A	Flare Slope RT (%)	N/A
N/A	Flare Traversable LT?	N/A	N/A	Flare Traversable RT?	N/A
N/A	Landing Length (in)	N/A	N/A	DWS Provided?	N/A
N/A	Landing Width (in)	N/A	N/A	DWS Contrast?	N/A
N/A	Landing Slope (%)	N/A	N/A	DWS Length (in)	N/A
N/A	Landing X Slope (%)	N/A	N/A	DWS Full Width?	N/A
N/A	Landing Curb? (Y/N)	N/A	N/A	DWS Offset (in)	N/A
N/A	Shared Landing?	N/A			
N/A	Gutter Ponding?	N/A	N/A	Gutter Slope (%)	N/A
N/A	Gutter Lip Ht (in)	N/A	N/A	Gutter X Slope (%)	N/A
N/A	Painted X Walk1?	No	N/A	Painted X Walk2?	N/A
	X Walk 1 Direction	To N		X Walk 2 Direction	N/A
N/A	X Walk 1 Width (in)	N/A	N/A	X Walk 2 Width (in)	N/A
	X Walk 1 Slope (%)	0.1		X Walk 2 Slope (%)	N/A
	X Walk 1 X Slope (%)	3.8		X Walk 2 X Slope (%)	N/A

Remove & Replace Entire Ramp.
