Access Compliance Report

Public Rights-of-Way

(Curb Ramps)

Intersection ID: 43138	Main Street: ASBURY_AV	Cross Street: ATANDO_AV	Location: NE
ADA ID: 68027F4B9798	Ramp Type: ParaDiag	Initial Pass/Fail: Fail	Overall Compliance: No
Severity Score: 13.75			
Codes/Mitigation Info/Possible Solution		Field Measurements/Component Compliance

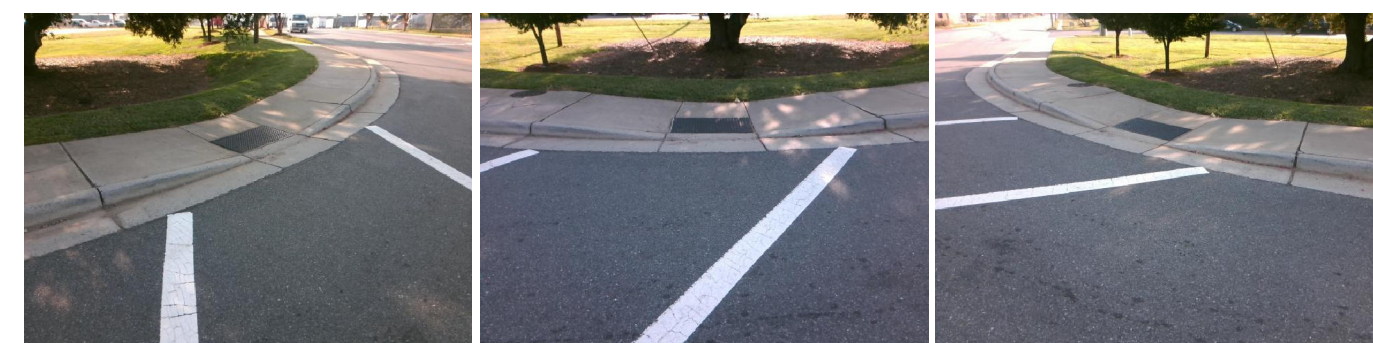
Compliance	Description	Data	Compliance	Description	Data
N/A	Ramp Length LT (in)	N/A	N/A	Ramp Length RT (in)	60.0
N/A	Ramp Width LT (in)	N/A	Yes	Ramp Width RT (in)	59.0
N/A	Ramp Slope LT (%)	N/A	No	Ramp Slope RT (%)	9.5
N/A	Ramp XSlope LT (%)	N/A	No	Ramp XSlope RT (%)	3.0
N/A	Landing Length (in)	N/A	N/A	DWS Provided?	N/A
N/A	Landing Width (in)	N/A	N/A	DWS Contrast?	N/A
N/A	Landing Slope (%)	N/A	N/A	DWS Length (in)	N/A
N/A	Landing X Slope (%)	N/A	N/A	DWS Full Width?	N/A
N/A	Landing Curb? (Y/N)	N/A	N/A	DWS Offset (in)	N/A
N/A	Shared Landing?	N/A			
N/A	Gutter Ponding?	N/A	N/A	Gutter Slope (%)	N/A
N/A	Gutter Lip Ht (in)	N/A	N/A	Gutter X Slope (%)	N/A
N/A	Painted X Walk1?	No	N/A	Painted X Walk2?	No
	X Walk 1 Direction	To NW		X Walk 2 Direction	To SW
N/A	X Walk 1 Width (in)	N/A	N/A	X Walk 2 Width (in)	N/A
	X Walk 1 Slope (%)	4.9		X Walk 2 Slope (%)	0.2
	X Walk 1 X Slope (%)	0.6		X Walk 2 X Slope (%)	3.5
N/A	Ramp inside XWalk1?	N/A	N/A	Ramp inside XWalk2?	N/A

Road Slope (%)	1.6	N/A	Clear Space?	N/A
	Road X Slope (%)	0.8	N/A	Clear Space to XWalk (in)	N/A
N/A	Any Obstructions?	N/A	N/A	Storm Grate/Utility Hazard?	N/A
	Obstruction Type			Storm Grate/Utility Type	
		N/A			N/A
			Yes	Surface Condition? (G/P)	Good
			N/A	Curb Slope (%)	N/A

Remove & Replace Curb Ramp With Two New Directional Ramps or Equivalent.
