# Access Compliance Report

## Public Rights-of-Way

### (Curb Ramps)

| Intersection ID: 11799 | Main Street: MECKLENBURG_AV | Cross Street: NORCROSS_PL | Location: | S |

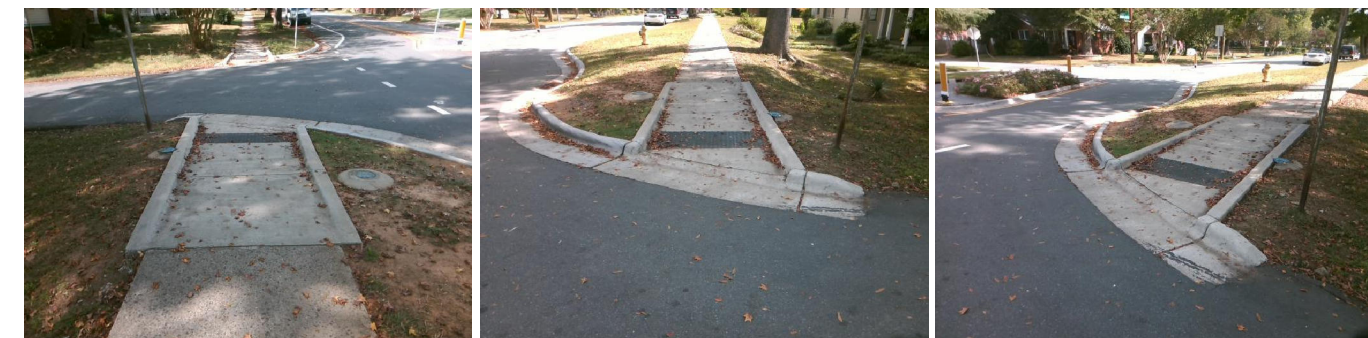
| Compliance | Description | Data | Compliance | Description | Data |
|---|---|---|---|---|---|
| Yes | Ramp Width (in) | 62.0 | No | Grade Break Slope (%) | 5.5 |

**Remove & Replace Entire Ramp.  
Remove & Replace Gutter.**
