Access Compliance Report

Public Rights-of-Way

(Curb Ramps)

Intersection ID: 10025681	Main Street: EAST_BV	Cross Street: N/A	Location: SW
ADA ID: 69379D0ACC3B	Ramp Type: Perp	Initial Pass/Fail: Fail	Overall Compliance: No
			Severity Score: 13.75

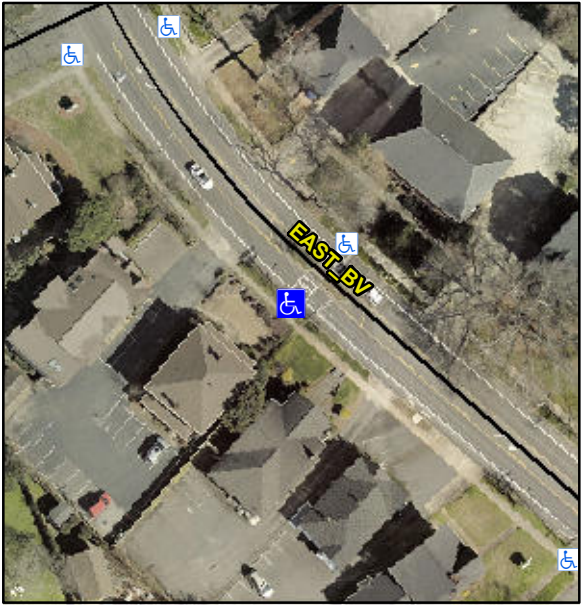
Possible Solutions:		Compliance	Description	Data
	Remove & Replace Entire Ramp.		No	Ramp Slope (%)	9.1
			Yes	Ramp Width (in)	2.7
			N/A	Flare Type LT	N/A
			N/A	Flare Slope LT (%)	N/A
			N/A	Flare Traversable LT?	N/A
			N/A	Landing Length (in)	N/A
			N/A	Landing Width (in)	N/A
			N/A	Landing Slope (%)	N/A
			N/A	Landing X Slope (%)	N/A
<p>Surveyor Notes:</p> <p>N/A</p> <p>PROW/ADA:</p> <p>Not Found, R304.2.2</p>			N/A	Flare Type RT	N/A
			N/A	Flare Slope RT (%)	N/A
			N/A	Flare Traversable RT?	N/A
			N/A	DWS Provided?	N/A
			N/A	DWS Contrast?	N/A
			N/A	DWS Length (in)	N/A
			N/A	DWS Full Width?	N/A
			N/A	DWS Offset (in)	N/A
			N/A	Gutter Ponding?	N/A
			N/A	Gutter Lip Ht (in)	N/A
			Yes	Painted X Walk1?	N/A
			To NE	X Walk 2 Direction	N/A
			N/A	X Walk 2 Width (in)	N/A

1.9	X Walk 2 Slope (%)	N/A
			4.0	X Walk 2 X Slope (%)	N/A
			N/A	Ramp inside XWalk2?	N/A
			N/A	Clear Space?	N/A
			N/A	Clear Space to XWalk (in)	N/A
			N/A	Storm Grate/Utility Hazard?	N/A
			N/A	Storm Grate/Utility Type	N/A
Total Cost:		\$ 1850.00			
			N/A		N/A
			Yes	Surface Condition? (G/P)	Good
