Access Compliance Report

Public Rights-of-Way

(Curb Ramps)

Intersection ID: 45239	Main Street: BROOKWOOD_RD	Cross Street: CALDWELL_RD	Location: S
ADA ID: 6943C539ECA5	Ramp Type: Combination1	Initial Pass/Fail: Fail	Overall Compliance: No
		Severity Score: 22.5

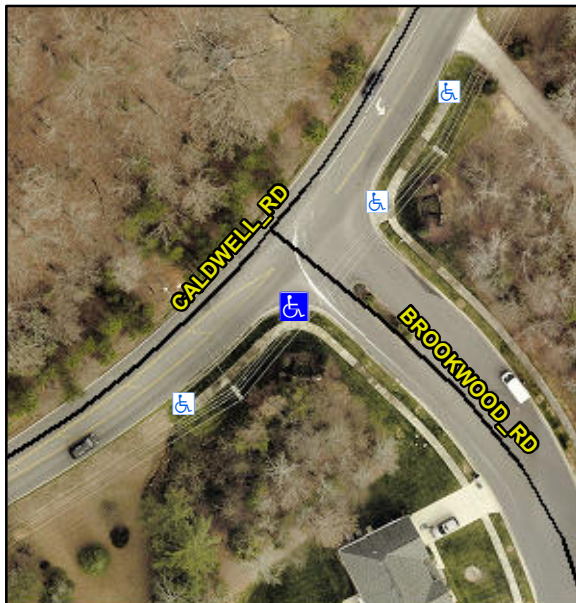
CURB GAP 1.0

Not Found, R304.5.1, R304.5.3, R304.3.2

Compliance	Description	Data	Compliance	Description	Data
N/A	Ramp Length LT (in)	34.5	N/A	Ramp Length RT (in)	34.5
Yes	Ramp Width LT (in)	55.0	Yes	Ramp Width RT (in)	55.5
Yes	Ramp Slope LT (%)	6.5	No	Ramp Slope RT (%)	10.1
No	Ramp XSlope LT (%)	4.4	No	Ramp XSlope RT (%)	3.0
N/A	Ramp Length (in)	76.0	Yes	Ramp Slope (%)	4.0
No	Ramp Width (in)	47.5	No	Ramp XSlope (%)	4.9
N/A	Flare Type LT	N/A	N/A	Flare Type RT	N/A
N/A	Flare Slope LT (%)	N/A	N/A	Flare Slope RT (%)	N/A
N/A	Flare Traversable LT?	N/A	N/A	Flare Traversable RT?	N/A
N/A	Landing Length (in)	N/A	N/A	DWS Provided?	N/A
N/A	Landing Width (in)	N/A	N/A	DWS Contrast?	N/A
N/A	Landing Slope (%)	N/A	N/A	DWS Length (in)	N/A
N/A	Landing X Slope (%)	N/A	N/A	DWS Full Width?	N/A
N/A	Landing Curb? (Y/N)	N/A	N/A	DWS Offset (in)	N/A
N/A	Shared Landing?	N/A			
N/A	Gutter Ponding?	N/A	N/A	Gutter Slope (%)	N/A
N/A	Gutter Lip Ht (in)	N/A	N/A	Gutter X Slope (%)	N/A
N/A	Painted X Walk1?	No	N/A	Painted X Walk2?	N/A

X Walk 1 Direction	To NE		X Walk 2 Direction	N/A
	X Walk 1 Width (in)	N/A		X Walk 2 Width (in)	N/A
	X Walk 1 Slope (%)	3.2		X Walk 2 Slope (%)	N/A
	X Walk 1 X Slope (%)	6.8		X Walk 2 X Slope (%)	N/A
N/A	Ramp inside XWalk1?	N/A	N/A	Ramp inside XWalk2?	N/A
	Road Slope (%)	N/A		Clear Space?	N/A
	Road X Slope (%)	N/A	N/A	Clear Space to XWalk (in)	N/A
			N/A	Any Obstruction?	N/A
				Obstruction Type	N/A
			N/A	Storm Grate/Utility Hazard?	N/A
				Storm Grate/Utility Type	N/A
					N/A
Yes	Surface Condition? (G/P)	Good			
	Curb Slope (%)	15.7

Remove & Replace Entire Ramp.
