Access Compliance Report

Public Rights-of-Way (Curb Ramps)

Intersection ID: 9716	Main Street: N_GREGG_ST	Cross Street: W_TRADE_ST	Location: W
ADA ID: 6B266AEE43C8	Ramp Type: Combination1	Initial Pass/Fail: Fail	Overall Compliance: No
			Severity Score: 46.25

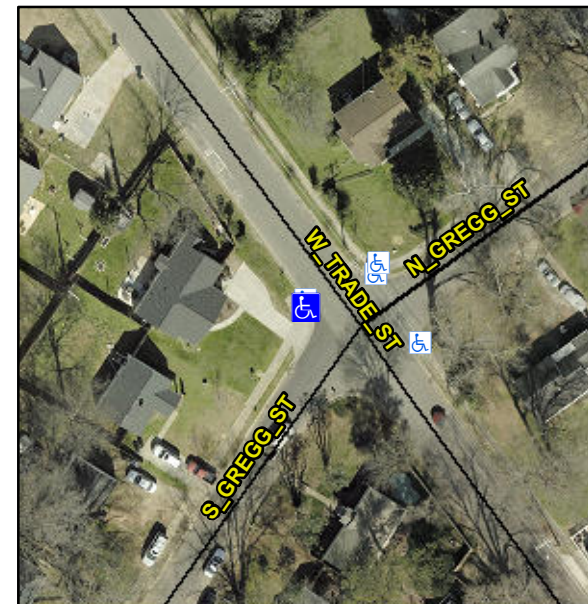
RT RP < 5%

Not Found, R304.5.1, R304.2.2, R304.5.3

Compliance	Description	Data	Compliance	Description	Data
N/A	Ramp Length LT (in)	33.0	N/A	Ramp Length RT (in)	52.0
Yes	Ramp Width LT (in)	62.0	Yes	Ramp Width RT (in)	62.0
Yes	Ramp Slope LT (%)	5.0	Yes	Ramp Slope RT (%)	4.3
No	Ramp XSlope LT (%)	7.4	No	Ramp XSlope RT (%)	6.6
N/A	Ramp Length (in)	108.0	No	Ramp Slope (%)	9.2
No	Ramp Width (in)	46.5	No	Ramp XSlope (%)	4.2
N/A	Flare Type LT	N/A	N/A	Flare Type RT	N/A
N/A	Flare Slope LT (%)	N/A	N/A	Flare Slope RT (%)	N/A
N/A	Flare Traversable LT?	N/A	N/A	Flare Traversable RT?	N/A
N/A	Landing Length (in)	N/A	N/A	DWS Provided?	N/A
N/A	Landing Width (in)	N/A	N/A	DWS Contrast?	N/A
N/A	Landing Slope (%)	N/A	N/A	DWS Length (in)	N/A
N/A	Landing X Slope (%)	N/A	N/A	DWS Full Width?	N/A
N/A	Landing Curb? (Y/N)	N/A	N/A	DWS Offset (in)	N/A
N/A	Shared Landing?	N/A			
N/A	Gutter Ponding?	N/A	N/A	Gutter Slope (%)	N/A
N/A	Gutter Lip Ht (in)	N/A	N/A	Gutter X Slope (%)	N/A
N/A	Painted X Walk1?	No	N/A	Painted X Walk2?	N/A

Remove & Replace Entire Ramp.
