Access Compliance Report

Public Rights-of-Way

(Curb Ramps)

Intersection ID: 47853	Main Street: EL_CAMPO_CT	Cross Street: STONE_PORCH_RD	Location: SW
ADA ID: 6BCCD598EB8A	Ramp Type: PerpDiag	Initial Pass/Fail: Fail	Overall Compliance: No
Severity Score: 35			
Codes/Mitigation Info/Possible Solution		Field Measurements/Component Compliance

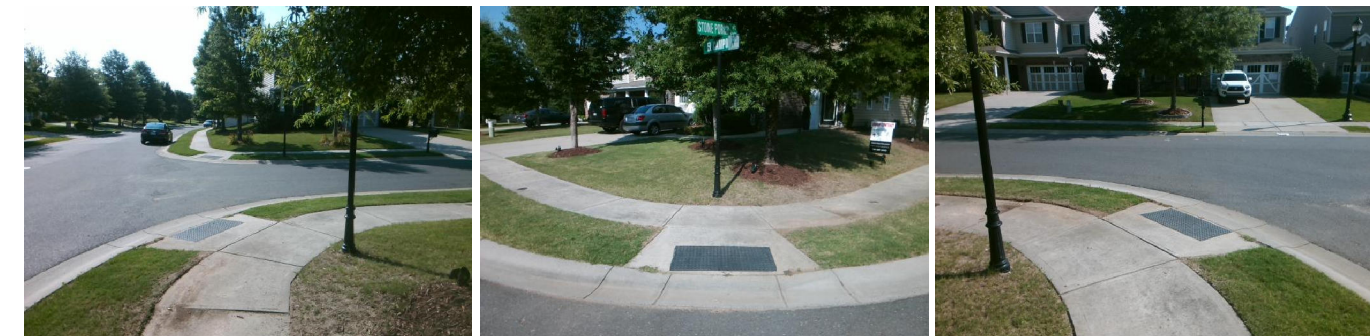
Not Found, R304.5.1, R304.2.2, R304.5.3

Compliance	Description	Data	Compliance	Description	Data
N/A	Ramp Length (in)	48.0	No	Ramp Slope (%)	12.0
No	Ramp Width (in)	45.0	No	Ramp XSlope (%)	2.9
N/A	Flare Type LT	N/A	N/A	Flare Type RT	N/A
N/A	Flare Slope LT (%)	N/A	N/A	Flare Slope RT (%)	N/A
N/A	Flare Traversable LT?	N/A	N/A	Flare Traversable RT?	N/A
N/A	Landing Length (in)	N/A	N/A	DWS Provided?	N/A
N/A	Landing Width (in)	N/A	N/A	DWS Contrast?	N/A
N/A	Landing Slope (%)	N/A	N/A	DWS Length (in)	N/A
N/A	Landing X Slope (%)	N/A	N/A	DWS Full Width?	N/A
N/A	Landing Curb? (Y/N)	N/A	N/A	DWS Offset (in)	N/A
N/A	Shared Landing?	N/A			
N/A	Gutter Ponding?	N/A	N/A	Gutter Slope (%)	N/A
N/A	Gutter Lip Ht (in)	N/A	N/A	Gutter X Slope (%)	N/A
N/A	Painted X Walk1?	No	N/A	Painted X Walk2?	No
	X Walk 1 Direction	To SE		X Walk 2 Direction	To NE
N/A	X Walk 1 Width (in)	N/A	N/A	X Walk 2 Width (in)	N/A
	X Walk 1 Slope (%)	1.3		X Walk 2 Slope (%)	2.7
	X Walk 1 X Slope (%)	0.8		X Walk 2 X Slope (%)	1.0

N/A	Ramp inside XWalk1?	N/A	N/A	Ramp inside XWalk2?	N/A
	Road Slope (%)	1.4	N/A	Clear Space?	N/A
	Road X Slope (%)	0.8	N/A	Clear Space to XWalk (in)	N/A
N/A	Any Obstructions?	N/A	N/A	Storm Grate/Utility Hazard?	N/A
	Obstruction Type			Storm Grate/Utility Type	
		N/A			N/A
			Yes	Surface Condition? (G/P)	Good

Remove & Replace Curb Ramp With Two New Directional Ramps or Equivalent.
