Access Compliance Report

Public Rights-of-Way

(Curb Ramps)

Intersection ID: 10029517	Main Street: KENTLAND_LN	Cross Street: FLAGSTAFF_DR	Location:	E
ADA ID: 6F4098FBDCF6	Ramp Type: Combination1Diag	Initial Pass/Fail: Fail	Overall Compliance: No	Severity Score: 0

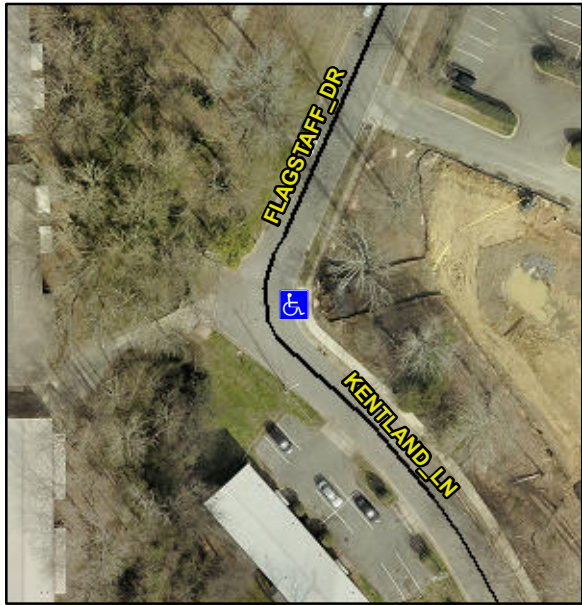
Possible Solutions:			Compliance	Description	Data	Compliance	Description	Data
	Remove & Replace Curb Ramp With Two New Directional Ramps or Equivalent.			N/A	Ramp Length LT (in)	83.0	N/A	Ramp Length RT (in)	N/A
				Yes	Ramp Width LT (in)	49.0	N/A	Ramp Width RT (in)	N/A
				No	Ramp Slope LT (%)	8.6	N/A	Ramp Slope RT (%)	N/A
				No	Ramp XSlope LT (%)	3.3	N/A	Ramp XSlope RT (%)	N/A
				N/A	Ramp Length (in)	55.0	Yes	Ramp Slope (%)	7.1
				Yes	Ramp Width (in)	49.0	Yes	Ramp XSlope (%)	0.9
	Surveyor Notes:			N/A	Flare Type LT	N/A	N/A	Flare Type RT	N/A
	N/A			N/A	Flare Slope LT (%)	N/A	N/A	Flare Slope RT (%)	N/A
				N/A	Flare Traversable LT?	N/A	N/A	Flare Traversable RT?	N/A
PROW/ADA:			N/A	Landing Length (in)	N/A	N/A	DWS Provided?	N/A	
Not Found, R304.3.2, R304.5.3			N/A	Landing Width (in)	N/A	N/A	DWS Contrast?	N/A	
			N/A	Landing Slope (%)	N/A	N/A	DWS Length (in)	N/A

N/A	Landing X Slope (%)	N/A	N/A	DWS Full Width?	N/A	
			N/A	Landing Curb? (Y/N)	N/A	N/A	DWS Offset (in)	N/A	
			N/A	Shared Landing?	N/A				
			N/A	Gutter Ponding?	N/A	N/A	Gutter Slope (%)	N/A	
			N/A	Gutter Lip Ht (in)	N/A	N/A	Gutter X Slope (%)	N/A	
			N/A	Painted X Walk1?	No	N/A	Painted X Walk2?	No	
				X Walk 1 Direction	To NW		X Walk 2 Direction	To SW	
				X Walk 1 Width (in)	N/A		X Walk 2 Width (in)	N/A	
				X Walk 1 Slope (%)	3.1		X Walk 2 Slope (%)	1.1	
				X Walk 1 X Slope (%)	2.0		X Walk 2 X Slope (%)	3.3	
Total Cost:			N/A	Ramp inside XWalk1?	N/A	N/A	Ramp inside XWalk2?	N/A	
				Road Slope (%)	1.1		Clear Space?	N/A	
				Road X Slope (%)	1.4	N/A	Clear Space to XWalk (in)	N/A	
						N/A	Any Obstruction?	N/A	
							Obstruction Type	N/A	
						N/A	Storm Grate/Utility Hazard?	N/A	
							Storm Grate/Utility Type	N/A	
			Yes	Surface Condition? (G/P)				N/A	
				Curb Slope (%)				Good
