# Access Compliance Report

## Public Rights-of-Way

### (Curb Ramps)

| Intersection ID: 10257 | Main Street: E_36TH_ST | Cross Street: N_MCDOWELL_ST | Location: N |

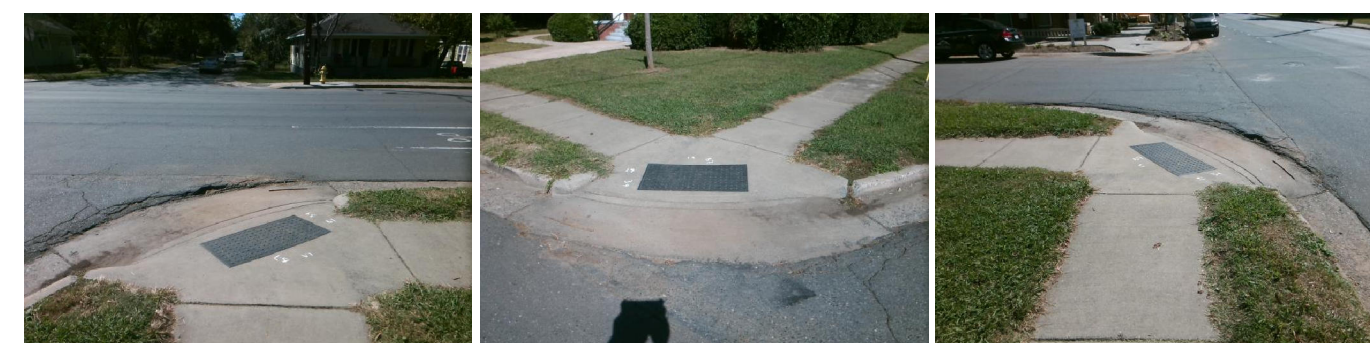
**Not Found, R304.2.2**

| Compliance | Description | Data | Compliance | Description | Data |
|---|---|---|---|---|---|
| N/A | Ramp Length (in) | 70.0 | No | Ramp Slope (%) | 8.7 |

**Remove & Replace Curb Ramp With Two New Directional Ramps or Equivalent.**
