# Access Compliance Report

## Public Rights-of-Way

### (Curb Ramps)

| Intersection ID: 46812 | Main Street: ARBOR_VISTA_DR | Cross Street: ADLIN_AV | Location: S |

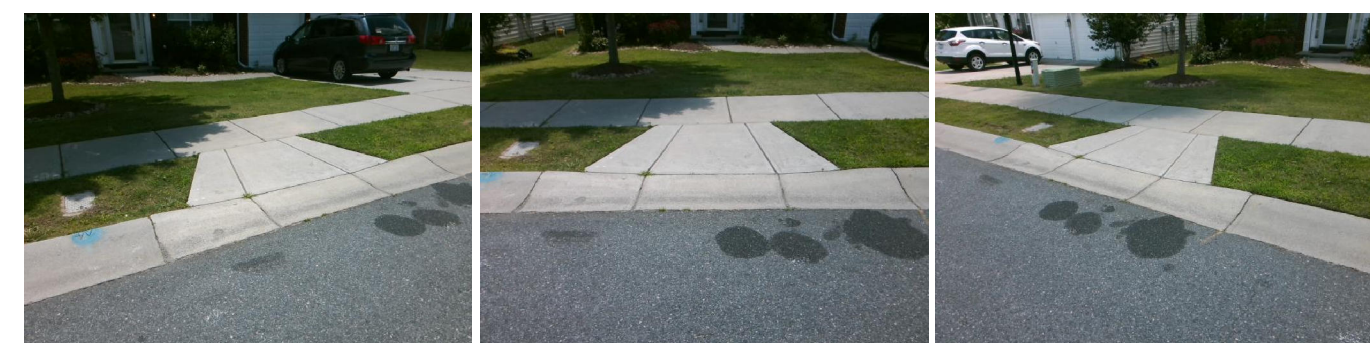
**Not Found, R304.5.1, R304.2.2, R304.5.3**

| Compliance | Description | Data | Compliance | Description | Data |
|---|---|---|---|---|---|
| N/A | Ramp Length (in) | 41.0 | No | Ramp Slope (%) | 8.4 |
| No | Ramp Width (in) | 38.0 | No | Ramp XSlope (%) | 2.2 |

**Remove & Replace Entire Ramp.**
