Access Compliance Report

Public Rights-of-Way (Curb Ramps)

Intersection ID: 3879	Main Street: DAVIS_LAKE_PY	Cross Street: DEER_CROSS_TL	Location: SE
ADA ID: 735394BF9976	Ramp Type: Perp	Initial Pass/Fail: Fail	Overall Compliance: No
		Severity Score: 35

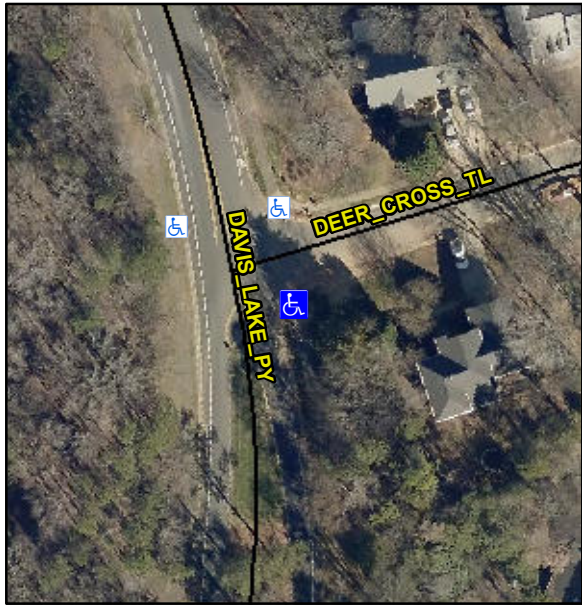
Possible Solutions:		Compliance	Description	Data	Compliance	Description	Data
	Remove & Replace Entire Ramp.		N/A	Ramp Length (in)	44.0	No	Ramp Slope (%)	24.2
			No	Ramp Width (in)	42.0	No	Ramp XSlope (%)	2.8
			N/A	Flare Type LT	N/A	N/A	Flare Type RT	N/A
			N/A	Flare Slope LT (%)	N/A	N/A	Flare Slope RT (%)	N/A
			N/A	Flare Traversable LT?	N/A	N/A	Flare Traversable RT?	N/A
			N/A	Landing Length (in)	N/A	N/A	DWS Provided?	N/A
			N/A	Landing Width (in)	N/A	N/A	DWS Contrast?	N/A
			N/A	Landing Slope (%)	N/A	N/A	DWS Length (in)	N/A
			N/A	Landing X Slope (%)	N/A	N/A	DWS Full Width?	N/A
Surveyor Notes:			N/A	Landing Curb? (Y/N)	N/A	N/A	DWS Offset (in)	N/A
N/A			N/A	Shared Landing?	N/A			
PROW/ADA:			N/A	Gutter Ponding?	N/A	N/A	Gutter Slope (%)	N/A
Not Found, R304.5.1, R304.2.2, R304.5.3			N/A	Gutter Lip Ht (in)	N/A	N/A	Gutter X Slope (%)	N/A

N/A	Painted X Walk1?	No	N/A	Painted X Walk2?	N/A
				X Walk 1 Direction	To N		X Walk 2 Direction	N/A
			N/A	X Walk 1 Width (in)	N/A	N/A	X Walk 2 Width (in)	N/A
				X Walk 1 Slope (%)	1.6		X Walk 2 Slope (%)	N/A
				X Walk 1 X Slope (%)	0.6		X Walk 2 X Slope (%)	N/A
			N/A	Ramp inside XWalk1?	N/A	N/A	Ramp inside XWalk2?	N/A
				Road Slope (%)	N/A	N/A	Clear Space?	N/A
				Road X Slope (%)	N/A	N/A	Clear Space to XWalk (in)	N/A
			N/A	Any Obstructions?	N/A	N/A	Storm Grate/Utility Hazard?	N/A
				Obstruction Type			Storm Grate/Utility Type	
						N/A		N/A
						Yes	Surface Condition? (G/P)	Good
