# Access Compliance Report

## Public Rights-of-Way

### (Curb Ramps)

| Intersection ID: 9061 | Main Street: LUCENA_ST | Cross Street: NORRIS_AV | Location: W |

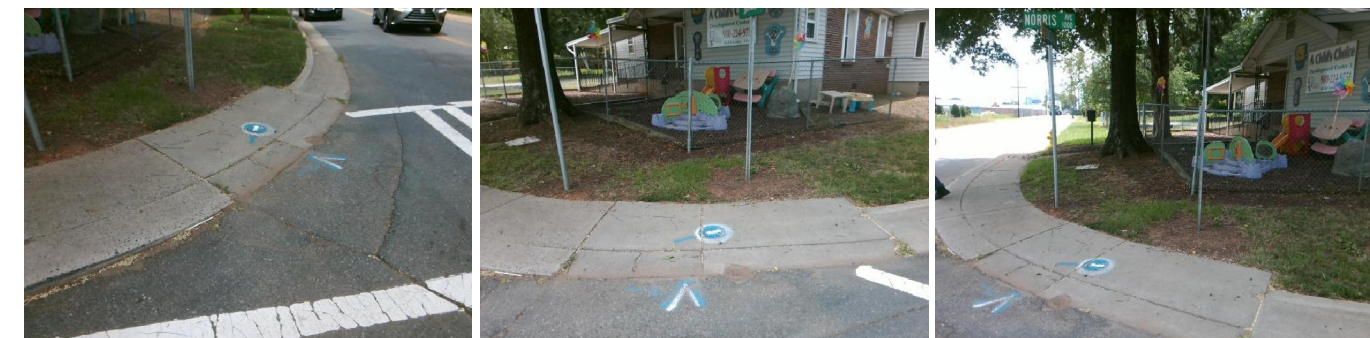
**Not Found, R304.5.1, R304.2.2**

| Compliance | Description | Data | Compliance | Description | Data |
|---|---|---|---|---|---|
| N/A | Ramp Length (in) | 39.0 | No | Ramp Slope (%) | 11.4 |
| No | Ramp Width (in) | 40.5 | Yes | Ramp XSlope (%) | 1.8 |

**Remove & Replace Curb Ramp With Two New Directional Ramps or Equivalent.**
