# Access Compliance Report

## Public Rights-of-Way

### (Curb Ramps)

| Intersection ID: 3072 | Main Street: PANTHERSVILLE_DR | Cross Street: PROSPERITY_CHURCH_RD | Location: S |

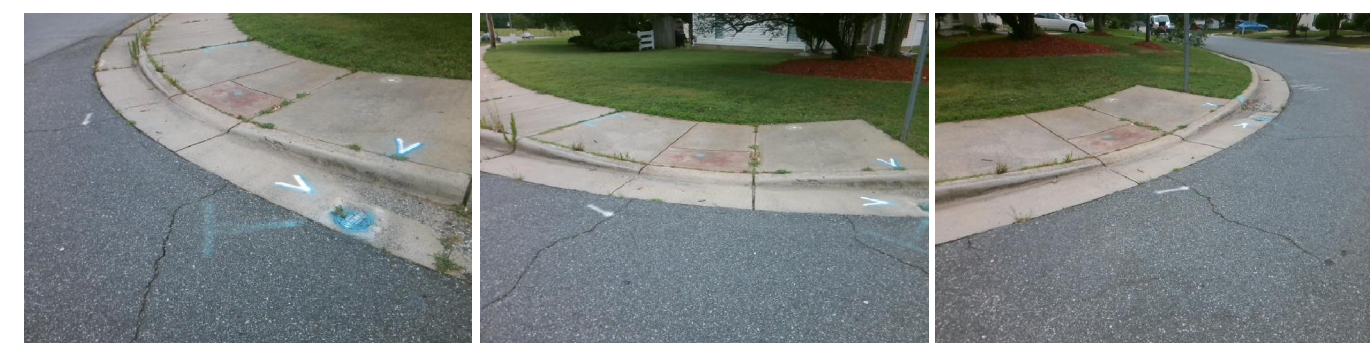
| ADA ID: 766AB24BC15E | Ramp Type: Perp | Initial Pass/Fail: Fail | Overall Compliance: No |
| Severity Score: 33.75 | | | |

**R304.5.1, R304.2.2**

| Compliance | Description | Data | Compliance | Description | Data |
|---|---|---|---|---|---|
| N/A | Ramp Length (in) | 24.0 | No | Ramp Slope (%) | 20.0 |
| No | Ramp Width (in) | 46.0 | Yes | Ramp XSlope (%) | 0.1 |

**Remove & Replace Entire Ramp.**
