Access Compliance Report

Public Rights-of-Way

(Curb Ramps)

Intersection ID: 29247	Main Street: CASTELLO_LN	Cross Street: MALLARD_FOREST_DR	Location: SW
ADA ID: 777AAD877417	Ramp Type: PerpDiag	Initial Pass/Fail: Fail	Overall Compliance: No
		Severity Score: 8.75

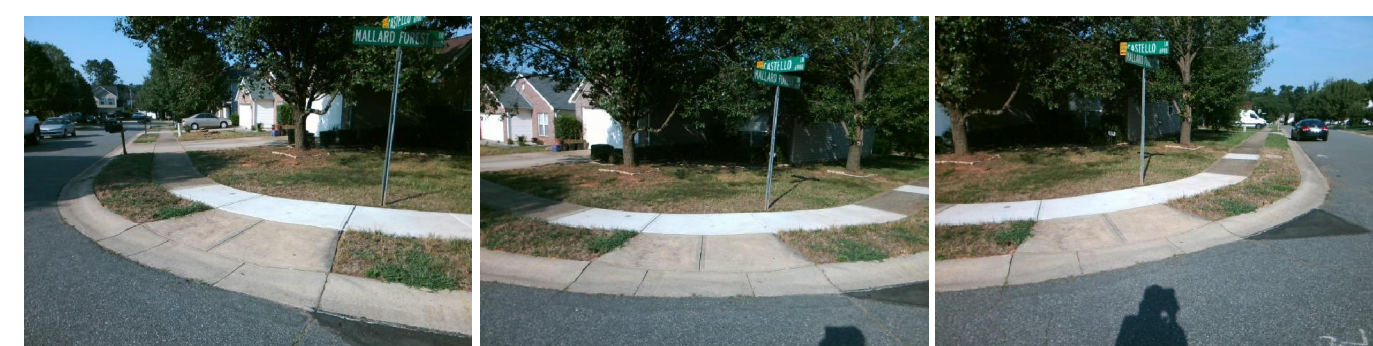
Possible Solutions:		Compliance	Description	Data
	Remove & Replace Curb Ramp With Two New Directional Ramps or Equivalent.		Yes	Ramp Length (in)	6.4
			No	Ramp Width (in)	1.0
			N/A	Flare Type LT	N/A
			N/A	Flare Slope LT (%)	N/A
			N/A	Flare Traversable LT?	N/A
			N/A	Landing Length (in)	N/A
			N/A	Landing Width (in)	N/A
			N/A	Landing Slope (%)	N/A
			N/A	Landing X Slope (%)	N/A
<p>Surveyor Notes:</p> <p>N/A</p> <p>PROW/ADA:</p> <p>R304.5.1</p>			N/A	Flare Type RT	N/A
			N/A	Flare Slope RT (%)	N/A
			N/A	Flare Traversable RT?	N/A
			N/A	DWS Provided?	N/A
			N/A	DWS Contrast?	N/A
			N/A	DWS Length (in)	N/A
			N/A	DWS Full Width?	N/A
			N/A	DWS Offset (in)	N/A
			N/A	Gutter Ponding?	N/A
			N/A	Gutter Lip Ht (in)	N/A
			No	Painted X Walk1?	No
				X Walk 1 Direction	To E
			N/A	X Walk 1 Width (in)	N/A

2.8	X Walk 1 Slope (%)	2.3
			3.7	X Walk 1 X Slope (%)	2.0
			N/A	Ramp inside XWalk1?	N/A
			0.0	Road Slope (%)	N/A
			6.0	Road X Slope (%)	N/A
			N/A	Any Obstructions?	N/A
				Obstruction Type	
Total Cost:		\$ 3200.00	N/A	Storm Grate/Utility Hazard?	N/A
			N/A	Storm Grate/Utility Type	
			Yes	Surface Condition? (G/P)	Good
