# Access Compliance Report

## Public Rights-of-Way

| Intersection ID: 31368 | Main Street: GREENWAY_VISTA_LN | Cross Street: LINDA_VISTA_LN | Location: | S |
| ADA ID: 779AFF1F9F02 | Ramp Type: BlendTrans1 | Initial Pass/Fail: Fail | Overall Compliance: No | Severity Score: 25 |

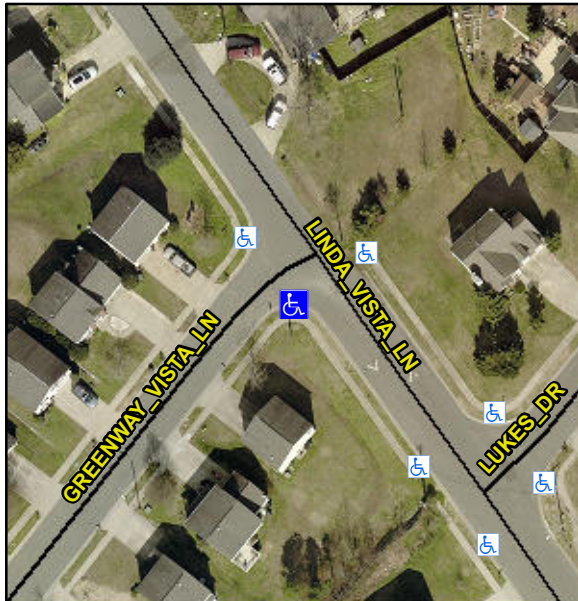
**R304.5.3**

| Compliance | Description | Data | Compliance | Description | Data |
|---|---|---|---|---|---|
| Yes | Ramp Width (in) | 48.0 | No | BlendTrans XSlope (%) | 7.9 |

**Remove & Replace Curb Ramp With Two New Directional Ramps or Equivalent.**
