Access Compliance Report

Public Rights-of-Way

(Curb Ramps)

Intersection ID: 28913	Main Street: ELIZABETH COLLINS BV	Cross Street: SPRINGBANK LN	Location: SW
ADA ID: 7820A95C4475	Ramp Type: PerpDiag	Initial Pass/Fail: Fail	Overall Compliance: No
Severity Score: 12.5			
Codes/Mitigation Info/Possible Solution		Field Measurements/Component Compliance

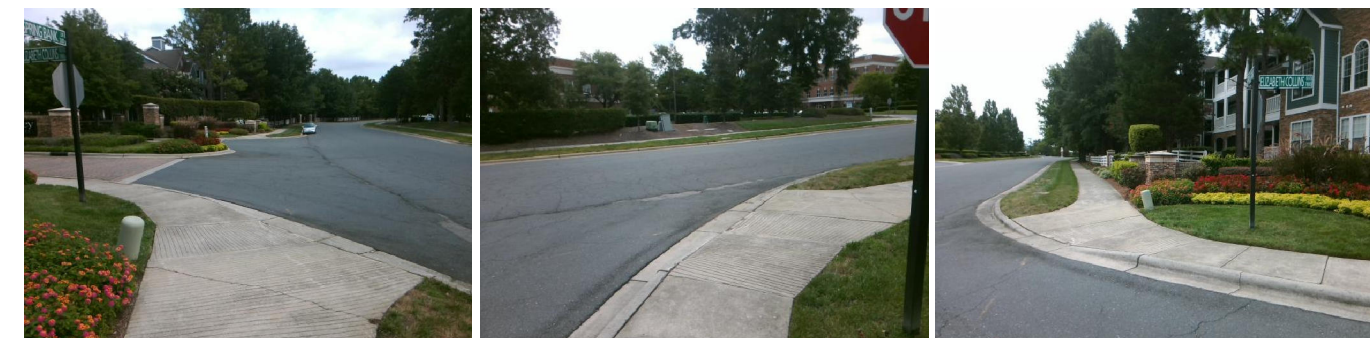
Not Found, R304.2.2

Compliance	Description	Data	Compliance	Description	Data
N/A	Ramp Length (in)	75.0	No	Ramp Slope (%)	9.8
Yes	Ramp Width (in)	52.0	Yes	Ramp XSlope (%)	1.3
N/A	Flare Type LT	N/A	N/A	Flare Type RT	N/A
N/A	Flare Slope LT (%)	N/A	N/A	Flare Slope RT (%)	N/A
N/A	Flare Traversable LT?	N/A	N/A	Flare Traversable RT?	N/A
N/A	Landing Length (in)	N/A	N/A	DWS Provided?	N/A
N/A	Landing Width (in)	N/A	N/A	DWS Contrast?	N/A
N/A	Landing Slope (%)	N/A	N/A	DWS Length (in)	N/A
N/A	Landing X Slope (%)	N/A	N/A	DWS Full Width?	N/A
N/A	Landing Curb? (Y/N)	N/A	N/A	DWS Offset (in)	N/A
N/A	Shared Landing?	N/A			
N/A	Gutter Ponding?	N/A	N/A	Gutter Slope (%)	N/A
N/A	Gutter Lip Ht (in)	N/A	N/A	Gutter X Slope (%)	N/A
N/A	Painted X Walk1?	No	N/A	Painted X Walk2?	No
	X Walk 1 Direction	To NE		X Walk 2 Direction	To NW
N/A	X Walk 1 Width (in)	N/A	N/A	X Walk 2 Width (in)	N/A
	X Walk 1 Slope (%)	5.9		X Walk 2 Slope (%)	3.9
	X Walk 1 X Slope (%)	1.5		X Walk 2 X Slope (%)	5.3

Remove & Replace Curb Ramp With Two New Directional Ramps or Equivalent.
